Faulty Isolator Handle

WHAT HAPPENED

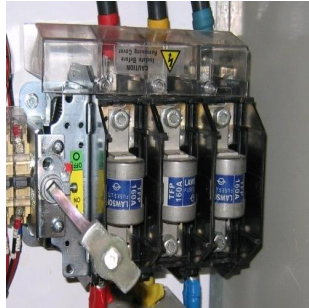
The manager turned off the isolator handle on the Fuse Combination Unit (FCU), (A typical FCU is shown in Photo No 1 below) this released the mechanical interlock allowing the cabinet to open.

On opening the 'failed' FCU it was found that the rocker 'cam' had sheared on two of the three phases leaving the incoming sliding contact in the closed position bridging the contact terminals

allowing power to flow through the fuses

There were no physical indications on the FCU to suggest that there was a problem of this magnitude.

Example of FCU

The FCU was replaced by a competent electrical contractor.

The Lock-Off and Isolation Procedures throughout the company must be amended to include testing every time that access is required inside a panel (to, for example, replace fuses or reset trips): to ensure that all parts to be handled are de-energised. The isolator handle cannot always be trusted to do this.
