# Truck Mixer Wedged Under Bridge

LOCATION:	ON-HIGHWAY
ACTIVITY:	TRANSPORT & LOGISTICS / DELIVERY
SUB ACTIVITY:	MOBILE PLANT

ALERT STATUS:	Normal
DATE ISSUED:	14/09/2011
INCIDENT No:	00311

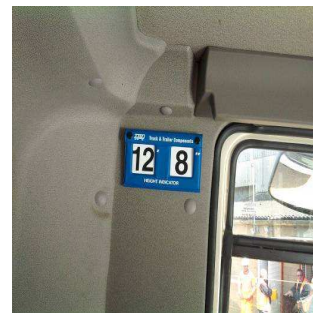
The police and Network Rail were informed and the railway closed for 46 minutes until the vehicle was freed by releasing air from the tyres. The investigation has found that the bridge height indication was 11ft 3 inches and when measured, the height of the truck was 12 ft 2 inches. The driver did not know the height of his vehicle and it was not indicated in his cab.

Height Indicator

- If a vehicles overall travelling height or trailer exceeds three meters there must be a notice in the cab, where it can be easily read by the driver.
- The notice must indicate the overall travelling height of the vehicle (to a tolerance of plus 150mm) in feet / inches or both feet / inches and meters, (but not in meters only).
- The numbers in feet/inches must be at least 40mm tall
- The requirement of the notice is not covered in an MOT test
- Importantly the driver must know the height of his vehicle and not take the risk.
