INCIDENT ALERT

LOCATION:	ON-HIGHWAY	ALERT STATUS:	Normal
ACTIVITY:	TRANSPORT / DELIVERY	DATE ISSUED:	14/09/2011
SUB ACTIVITY:	MOBILE PLANT	INCIDENT No:	00311

Truck Mixer Wedged Under Bridge

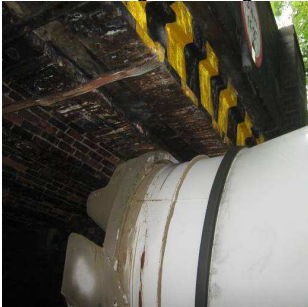
A truck mixer was carrying a load of concrete to a customer site, on route the driver encountered a low bridge and knew that it would be tight to go under the bridge, he slowed and put the vehicle in 1st gear. On exiting the bridge there was a steep incline causing the drum ring to wedge under the bridge. The vehicle could not go forwards or backwards.

Wedged under Low Bridge

- If a vehicles overall travelling height or trailer exceeds three meters there must be a notice in the cab, where it can be easily read by the driver.
- The notice must indicate the overall travelling height of the vehicle (to a tolerance of plus 150mm) in feet / inches or both feet / inches and meters, (but not in meters only).
- The numbers in feet/inches must be at least 40mm tall
- The requirement of the notice is not covered in an MOT test
- Importantly the driver must know the height of his vehicle and not take the risk.

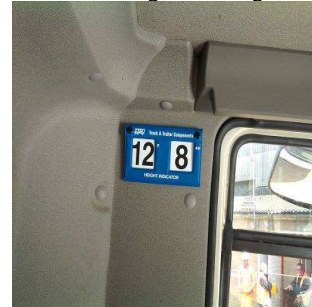
The police and Network Rail were informed and the railway closed for 46 minutes until the vehicle was freed by releasing air from the tyres. The investigation has found that the bridge height indication was 11ft 3 inches and when measured, the height of the truck was 12 ft 2 inches. The driver did not know the height of his vehicle and it was not indicated in his cab.

Height Indicator
