# Truck Mixer Driver Fall

READYMIX OR MORTAR PLANT  
TRANSPORT & LOGISTICS / DELIVERY  
MOBILE PLANT

ALERT STATUS: Normal  
DATE ISSUED: 12/12/2011  
INCIDENT No: 00318

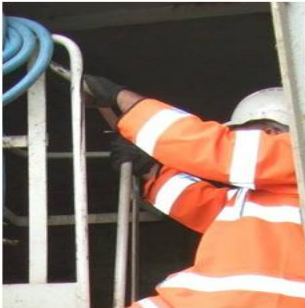
- As he descended the ladder, instead of holding onto both vertical hand rails he used the swing bar as one of his 3 points of contact:
  - Are employees and contractors reminded of the need to GET a GRIP, and maintain three secure points of contact when using ladders and stairways? Is this monitored by site supervision? In this case, the Driver relied on the self closing gate as a point of contact. Have we explained that hinge mechanisms on self closing gates and swing bars should not be used as hand holds? They can easily fail and, as happened in this incident, can cause a person to lose their grip and fall.

- The swing bar was bent out of shape causing it to close below its fixing bracket:
  - do we have robust inspection systems in place to ensure this type of defect is identified and corrective action taken?

Renactment showing driver holding swingbar
