# INCIDENT ALERT

**ALERT STATUS:** Normal  
**DATE ISSUED:** 27/03/2012  
**INCIDENT No:** 00330

**Tipper Tail Gate**

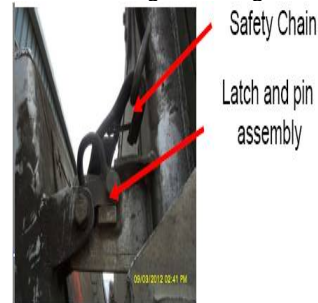
**Tail Gate Close Up**

The driver had put the lower tailgate up to clean the ledge and while carrying out the cleaning, the tailgate weighing Approx 50kg swung down, hitting him on the top of his safety helmet. Fortunately because he was wearing his safety helmet the driver did not suffer a very serious injury.

The investigation found that the tailgate latch had rested on the locating pin and had not fully secured, and the safety chain was not used.

- The safe system of work is followed
- The tailgate is secure
- The safety chain is used
- The correct PPE is worn, especially head protection (on this occasion it probably saved his life)!
- and that the company's haulier rules are followed. "Tailgates must be fitted with a minimum Hex Nut tailgate operation; ideally an automatic gate is preferred. Articulated trailer gates which operate by either gravity or pressure are acceptable"

Due to the design of this particular trailer a hexagon nut could not be fitted.
