Tipper Tail Gate

ALERT STATUS: Normal
DATE ISSUED: 27/03/2012
INCIDENT No: 00330

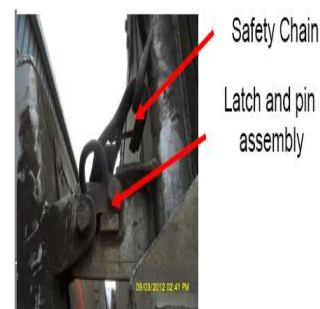
Tail Gate

The investigation found that the tailgate latch had rested on the locating pin and had not fully secured, and the safety chain was not used.

- The safe system of work is followed
- The tailgate is secure
- The safety chain is used
- The correct PPE is worn, especially head protection (on this occasion it probably saved his life)!
- and that the company's haulier rules are followed. "Tailgates must be fitted with a minimum Hex Nut tailgate operation; ideally an automatic gate is preferred. Articulated trailer gates which operate by either gravity or pressure are acceptable"

Due to the design of this particular trailer a hexagon nut could not be fitted.

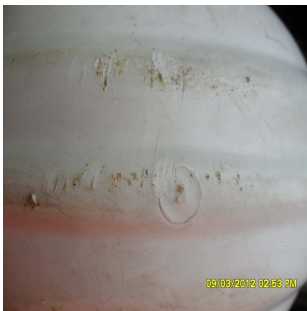
Hard Hat

The driver had put the lower tailgate up to clean the ledge and while carrying out the cleaning, the tailgate weighing Approx 50kg swung down, hitting him on the top of his safety helmet. Fortunately because he was wearing his safety helmet the driver did not suffer a very serious injury.
