INCIDENT ALERT

ALERT STATUS: Normal
DATE ISSUED: 08/01/2013
INCIDENT No: 00351

TITLE

Asphalt Wagon Doors

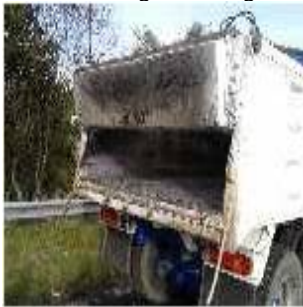
ACCIDENT / INCIDENT IMAGES

The operative had attempted to free the hydraulic tailgate on an asphalt wagon after it had become stuck whilst attempting to unload into the Paver's hopper.

The wagon driver had managed to raise the bottom of the tailgate using the hydraulic system, but the gate was only halfway open. The operative had then attempted to prise the tailgate open with a bar.

Due to the wagon's body being elevated, the product had rested against the tailgate. When the tailgate eventually became unstuck it swung out trapping the operatives hand between the tailgate's edge and the Paver hopper injuring his index finger and middle finger of his right hand.

The operative suffered a crush injury requiring 2 stitches to one of his fingers. He is very lucky because he could have easily lost his fingers or his hand if the incident had been more severe.

The procedure for opening tailgates at the company concerned has now been changed as follows;

At no time should a contracting operative touch the Asphalt wagon tailgate or attempt to free it by any means (Hydraulic or manual).

If the tailgate becomes stuck stop the operation and if in front of the paver get the driver to pull forward off the paver. It is the responsibility of the wagon driver to open his tailgate. If he cannot open his tailgate in a safe manner then he must take the vehicle off site and return to the Asphalt plant.
