# INCIDENT ALERT

**ALERT STATUS:** Normal  
**DATE ISSUED:** 08/01/2013  
**INCIDENT No:** 00353

**Unsafe Working with Telehandler**

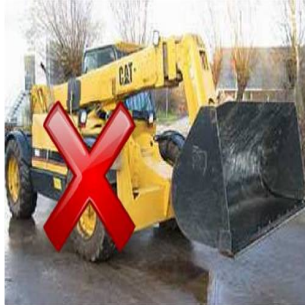
A recent near hit has highlighted that an operative was using a Telehandler bucket as a working platform.

Whilst riveting the Perspex roof sheeting onto a bike shed the operative used the bucket attached to the telehandler as a platform to gain sufficient height to perform the task.

If you need to use a Telehandler for access the correct working platform attachment **MUST** be used and you must be trained to fit and operate the platform safely.
