# Operator injures foot while replacing the cutting edge on loading shovel bucket

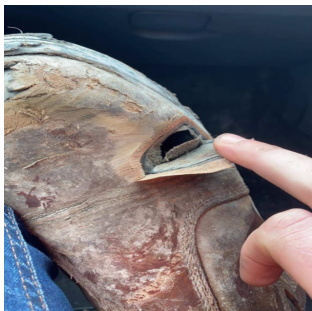
A trained operative was changing a cutting edge on a loading shovel bucket. The old edge had been removed and the base edge cleaned with a scraper (as per safe operating practice). Before fitting the new edge, the operative noticed some dirt remaining on the base edge and raised his foot to rub it off. The base edge was worn sharp like a razor and sliced through his safety boot, above the steel toecap and sliced the operative's foot. The operative required a trip to A&E and the wound required stitching. This resulted in a LOST TIME INJURY (LTI) as the operative was required to rest his foot to ease pressure on the stitches.

Damage to the boot above toe cap

Once the old cutting edge is removed, be aware that the base edge of a worn bucket can be very sharp NEVER run your hand or foot along the edge ALWAYS use a scraper or brush to clean the underside of the bucket, prior to fitting the new cutting edge.
