INCIDENT ALERT

ALERT STATUS: Normal
DATE ISSUED: 23/02/2021 20:21:41
INCIDENT No: 03587

Operator injures foot while replacing the cutting edge on loading shovel bucket

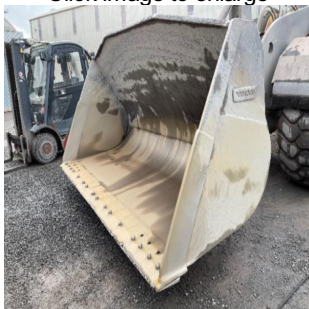
Once the old cutting edge is removed, be aware that the base edge of a worn bucket can be very sharp

Before - Bucket showing razor sharp edge

ALWAYS use a scraper or brush to clean the underside of the bucket, prior to fitting the new cutting edge.
