# Fatal 6 - Vehicle rollover – driver requires 24 stitches

<b>LOCATION:</b>	<b>ON-HIGHWAY</b>	<b>ALERT STATUS:</b>	<b>Normal</b>
<b>ACTIVITY:</b>	<b>TRANSPORT &amp; LOGISTICS / DELIVERY</b>	<b>DATE ISSUED:</b>	<b>18/08/2022 12:40:00</b>
<b>SUB ACTIVITY:</b>	<b>LOADING</b>	<b>INCIDENT No:</b>	<b>03626</b>

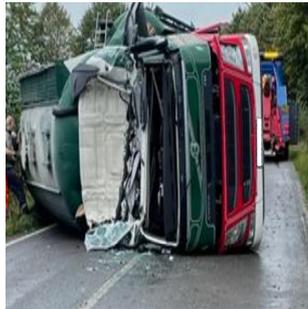
A contract tanker driver was travelling on the A515 when he lost control of the back end of the vehicle and it rolled over, skidding along the road and colliding with another vehicle. It is believed the movement on the back end of the vehicle was caused by catching the soft verge, and when the driver attempted to steer away from the verge this caused the vehicle to destabilise and tip over.

- The driver was wearing his seatbelt which saved him from more serious injury or even death.
- The driver was travelling at 32mph, well within the 50mph limit when the accident occurred.
- Weather conditions were poor with heavy rain and fog patches
- The driver was not using his mobile phone
- The driver had recently completed the MPQC Site Safety Awareness course which covers soft verge / rollover risk

- Remind drivers to wear their seatbelt...This helped avoid serious injuries in this incident.
- Drive to the weather conditions not to the speed limit; travelling significantly lower than the limit reduced the severity of this incident.
- Consider whether alternative routes are available that avoid known local hazard spots.
- Confirm Driver inductions make specific reference to known hazards, such as soft verges in this case.
- Liaise with local councils as appropriate to see if road improvements can be made.
