# TRANSPORT - Contractor slips and breaks his leg whilst walking along railway sidings

**LOCATION:** RAILHEAD  
**ACTIVITY:** TRANSPORT & LOGISTICS / DELIVERY  
**SUB ACTIVITY:** DELIVERING AGGREGATES

**ALERT STATUS:** Normal  
**DATE ISSUED:** 13/11/2023 17:51:45  
**INCIDENT No:** 03674

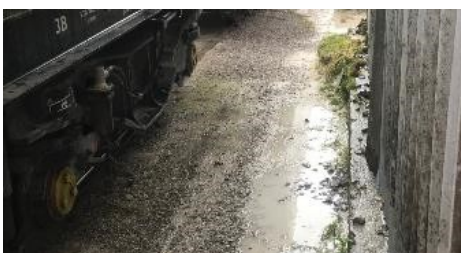
It was dark, ground conditions were wet and lighting in the area was limited. The operator slipped and fell to the ground injuring his ankle. He managed to get back on his feet and carried on with his duties until the end of the shift when he went home. He went to bed, but when he awoke his ankle was causing a lot of discomfort, so he went to hospital where an X-ray confirmed a fracture to the lower leg.

The images below show the damaged leg before the X-Ray and the location of the fall.

**Housekeeping** - The area by the rail shed was uneven, hidden by the wet conditions and poorly illuminated. There is a cleaning regime in place, but it didn't extend to this area.

**Lighting** - Head torches are issued by the contractor and should be used where required. General lighting in the area is good but potential for improvement opportunity in and around the loading shed.

- Ensure lighting is suitable and sufficient and ensure head torches are used as necessary.
- Ensuring ground conditions are even and slip free.

- Review conditions of regular walking routes and see how they can be improved including drainage, lighting and winter readiness.
- Ensure lighting is appropriate in working areas.
- Review Control of Contractors ensuring we know they have signed in/out.
- Enforce timely reporting of Incidents via the Accident Book
- Ensure all near miss hazard alerts (NMHAs) are captured on the company system
