# Fatal 5 - Readymix discharge cone and frame weighing 350 kg fall during cleaning operation due to mechanical failure

**LOCATION:** READYMIX OR MORTAR PLANT  
**ACTIVITY:** LIFTING  
**SUB ACTIVITY:** NO SUB ACTIVITY AVAILABLE

**ALERT STATUS:** High Potential  
**DATE ISSUED:** 14/03/2024 17:04:45  
**INCIDENT No:** 03700

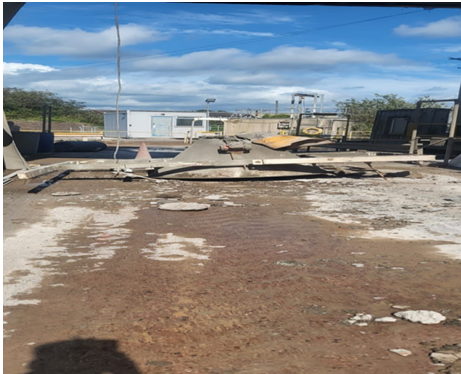
He had walked away to get tools to clean the cone when he heard a loud crash. He returned to the loading area to find the frame and discharge cone had fallen to the ground; it is estimated that the combined weight of the assembly was 350kg.

Initial investigations indicate that the split pins had sheared off the pivot point, combined with possible distortion in the frame, which allowed movement and the frame to detach from the pivot point. Fortunately, the Plant Manager was not in the line of fire when the failure occurred. Image below shows discharge cone and lifting frame on the ground.

**Preventative maintenance** - It is believed the split pins on the pivot end of the frame had sheared off through wear and tear and regular lowering of the frame assembly.

- Ensure maintenance regimes are effective and all load bearing parts of equipment such as pivot hinges are subject to routine inspections in accordance with manufacturer's specification.
- Split pins must be checked for wear to ensure equipment remains in alignment.

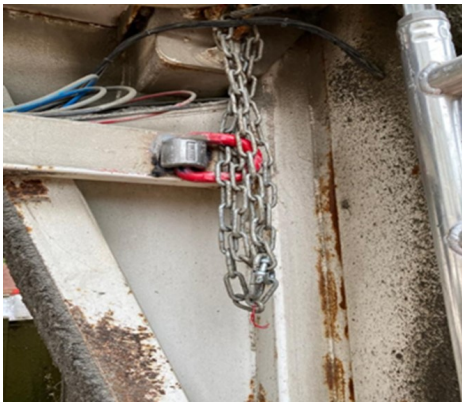
Image below shows heavy duty safety chains retrofitted to the pivot point on the lifting assembly.

- Consider installation of secondary safety chains with adequate Safe Working Load on the pivot sides of similar plants with a winch operated loading chute.
- Ensure plants are operated in strict accordance with manufacturer's guidelines.
- Ensure winches and fixing points are subject to required statutory inspection regimes.
- Are preventative maintenance regimes effective in highlighting defects to critical components?
- Control access to areas ensuring operators are not in the 'line of fire' when operating plant/equipment, consider exclusion zones/barriers.
- Do we ensure people STOP & THINK/Take-5 before completing tasks?
