# Fatal 5 - Operator hit by small media ball injuring tooth

**LOCATION:** CEMENT PLANT  
**ACTIVITY:** MAINTENANCE & HOUSEKEEPING  
**SUB ACTIVITY:** MILLS

**ALERT STATUS:** Normal  
**DATE ISSUED:** 03/04/2024 16:14:39  
**INCIDENT No:** 03704

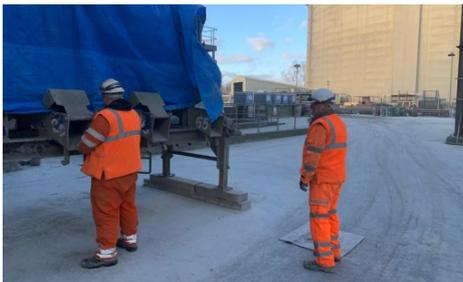
The image above shows a reconstruction of the operators positioning at time of incident, they were **2.5 metres** apart. Access to the area was being controlled. .

Although the likelihood of this incident occurring was extremely low, it is acknowledged that space constraints on site and the design of the media grader could impact its operation during wet weather (as the task is completed outdoors). The UK experienced the wettest weather in decades during the week in question. Consequently, cement accumulated on the discharge chutes, and the operator had to break it up by tapping a hammer on the coating. This action led to a trapped media ball falling through the chute and making unexpected contact with the hammer, causing it to be expelled from the chute towards the contractor.

To address this issue, newer grading machines with improved designs, less susceptible to material buildup during adverse weather conditions, will be hired for future use.
