# Fatal 1 - Contractor exposed himself to risk of being seriously injured in crusher by failing to follow procedures

LOCATION: QUARRY  
ACTIVITY: PRODUCTION AND PROCESSING  
SUB ACTIVITY: AGGREGATE PROCESSING

**ALERT STATUS:** High Potential  
DATE ISSUED: 05/08/2024 16:25:16  
INCIDENT No: 03728

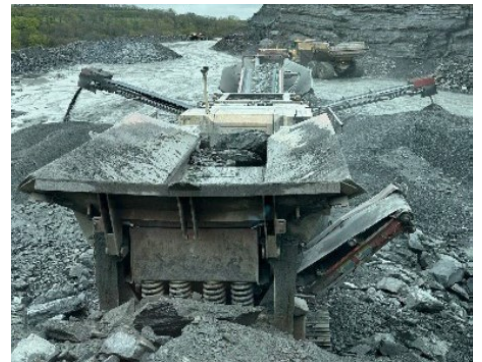
A contractor plant operator (agency labour) was found above the mobile crusher jaws attempting to clear bridged material. They had left the designated walkway, climbed over the handrails and had not implemented LOTOTO. The machine was running, the crusher jaws were turned off but the engine and conveyor were still operating.

- The worker did not follow the communication process as required by the Risk Assessment and Method Statement (RAMS)
- The worker was prepared to defeat the provided access restriction when they climbed over rails to access the mobile crushing area
- The worker was prepared to deviate from instruction and take action even though they knew they were not authorised.

- Review Task Authorisation process
- Review incident scene management
- More disciplined approach to maintaining contractor induction records
- Review site RAMS – including best practice
- Share report with agency

- Check task authorisation for long term contractors ([see MPA Guidance on Safequarry](#))
- National Ops meeting to discuss the standardisation of contractor management post incident where non-compliance is identified
- Review site safety meeting frequency and improve quality of record keeping
- National Ops meeting to discuss review of high hazard RAMS in line with 'The Fatal 6'
