Transport - Tipper driver injures leg when walking into Armco barrier

LOCATION:	READYMIX OR MORTAR PLANT	ALERT STATUS:	Normal
ACTIVITY:	TRANSPORT & LOGISTICS / DELIVERY	DATE ISSUED:	27/08/2024 12:20:26
SUB ACTIVITY:	DELIVERING AGGREGATES	INCIDENT No:	03730

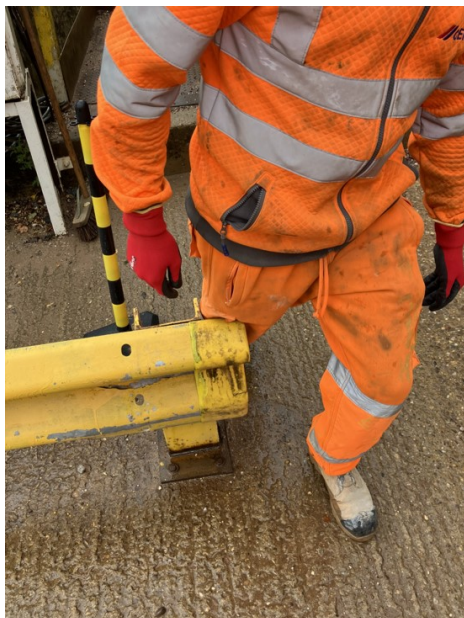
The exposed end of the Armco barrier was not protected. See below the before and after images, these show how a similar incident will be avoided by the changes made after this incident.

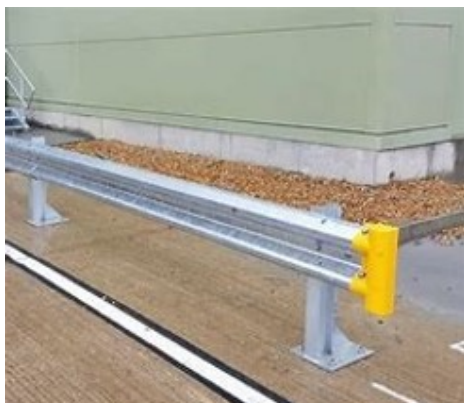
- Wherever possible, eliminate the need for driver / pedestrian movement on sites.
- Risk assess pedestrian areas for hazards such as slips, trips and falls, sharp edges, and unprotected pedestrian areas.
- Review pedestrian barriers to ensure there are no exposed sharp edges, for example by using end caps on Armco barriers, see image below.
