# Overhead Hoist Incident

## WHAT HAPPENED

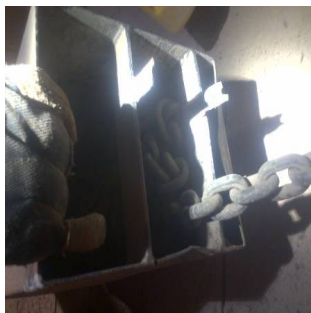
Investigations showed that the journals that attached the box to the hoist had failed.

Repeated impact over time had weakened the journals on the chain box that eventually failed

Broken journals on the chain box

Bolt on hoist to which the box is fixed

All overhead hoists to be serviced by a competent engineer and a schedule of services to be arranged at least twice a year.

Fit safety chains supplied by the providers to all chain boxes on overhead hoists.

Review the operations of all overhead hoists to ensure that lifted items are not striking the bottom of chain boxes routinely.

Where the head room between the chain hook and the bottom of the chain box is less than 1.0m, review fitting an ultimate limit switch to the hoist chain.

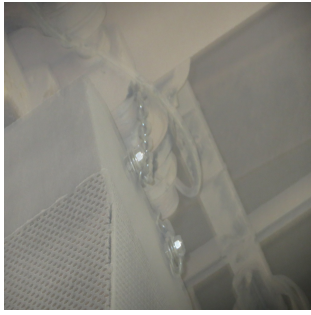
**Safety chain and new box fitted.**
