INCIDENT ALERT

LOCATION: CONCRETE PRODUCTS PLANT
ACTIVITY: TRANSPORT / DELIVERY
SUB ACTIVITY: MOBILE PLANT

ALERT STATUS: Normal
DATE ISSUED: 23/06/2014
INCIDENT No: 00383

Driver Struck By Falling Wall

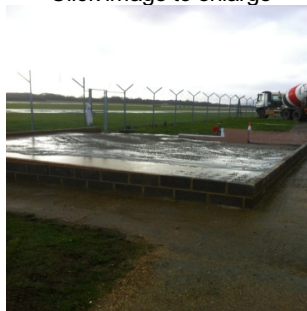
He had finished discharging the load and was preparing to wash down his truck chutes into an adjacent area of the slab as directed, when the concrete block wall collapsed and fell against his leg, knocking him over, trapping his right leg and causing him to knock his head against his truck's access ladder. The IHC was not wearing a hard hat.

The wall had collapsed in time with the raking motion of the site person who was leveling the slab. The IHC sustained a cut to his forehead, minor concrete burns to his arm and a more serious cut to his right shin which meant he was detained in hospital for 5 days and required a skin graft.

Scene of Incident

- The driver was not wearing his safety helmet whilst on site. Do all employees and contractors on site comply with company minimum personal protective equipment (PPE) standards? Are checks made during induction and site tours?

- No checks had been made to ensure drivers were complying with company standards or the customer site rules for the contract. Indeed there did not appear to be any communication between the site and plant and/or drivers regarding site conditions? Are post delivery service audits undertaken that include reference to IHC site safety?

- The driver considered the wall construction as suspect but had still put himself between his truck and the wall. Are drivers aware that they must report unsafe conditions and behaviours immediately? Do they consider their colleagues delivering to the same site? Is the near miss / hazard alert card system used by all personnel, including drivers? (MYSPACE is an initiative to encourage drivers to undertake a dynamic risk assessment, considering who/what can enter the area around their vehicle and the resulting risks).

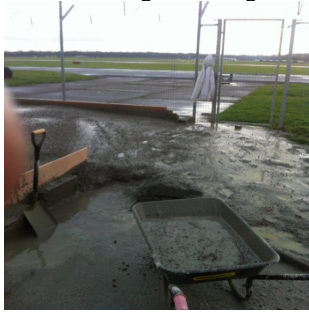
Spillage when wall collapsed
