# Bowser Driver Fall

ALERT STATUS: Normal  
DATE ISSUED: 19/12/2014 14:11:49  
INCIDENT No: 00395

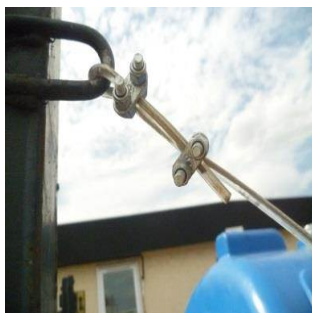
500kg plastic coated safety wire not to be used

The operator climbed onto the back of the vehicle but tripped / slipped whilst carrying out the task and as he reached out to grab the safety rope it came loose due to it not being fitted correctly.

The safety rope failed on sudden pressure being applied. This resulted in the driver falling 1 metre to the ground, fortunately landing on his feet he suffered a strain to his back which resulted in a Lost Time Injury. The consequence of such a fall could have been far worse.

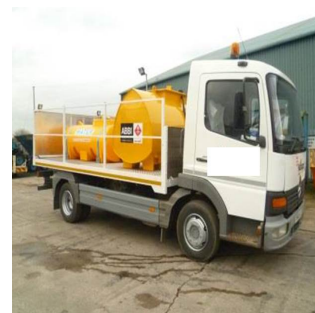
Rails no greater than 470mm apart

1-All bowzers brought in on short or long term hire will be ground fill. Where an operator has to climb onto the rear of the bowser it will be guarded with rails no greater than 470mm apart.
