Fitter Struck by Grinding Wheel

LOCATION:	COMPANY-WIDE	ALERT STATUS:	Normal
ACTIVITY:	MAINTENANCE & HOUSEKEEPING	DATE ISSUED:	08/01/2015 18:31:11
SUB ACTIVITY:	N/A	INCIDENT No:	00397

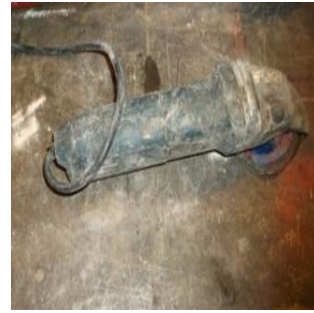
The Fitter then proceeded to cut into the guard with a hand held grinder, complete with a "thin" cutting disc, while the Manager held onto the guard at the opposite side. At approximately 1/3rd through the cut, the disc jammed, which caused the tool to shoot out of the Fitter's hands, hitting his left leg before falling to the floor; since it was not fitted with a hold to run switch, the grinder was still running.

Angle Grinder

maintained, tools / equipment for the job and never make do? Do you have adequate defect reporting and inspection systems for tools and machinery? Do powered hand tools have hold to run controls that cut the power when released?
