INCIDENT ALERT

LOCATION:	COMPANY-WIDE	ALERT STATUS:	Normal
ACTIVITY:	MAINTENANCE & HOUSEKEEPING	DATE ISSUED:	08/01/2015 18:31:11
SUB ACTIVITY:	N/A	INCIDENT No:	00397

Fitter Struck by Grinding Wheel

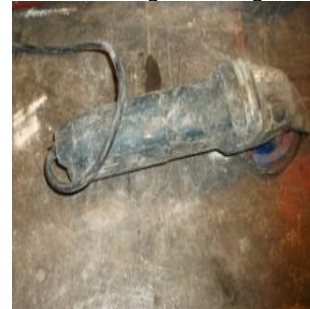
Angle Grinder

- The grinder did not have handle attached and it kept running when the Fitter lost his grip due to the power switch remaining engaged. The defect reporting system for powered hand tools was not being used at the site. Do you use the right, well maintained, tools / equipment for the job and never make do? Do you have adequate defect reporting and inspection systems for tools and machinery? Do powered hand tools have hold to run controls that cut the power when released?

- Though having received training, the Fitter was using the wrong disc for the activity being undertaken. Are personnel trained, competent and authorised for the full range of tasks they are required to carry out? Do they apply this training in the use and selection of the work methods and equipment they use?
