# Truck Wheel Loss

LOCATION:	ON-HIGHWAY	ALERT STATUS:	Normal
ACTIVITY:	TRANSPORT & LOGISTICS / DELIVERY	DATE ISSUED:	23/02/2015 12:15:58
SUB ACTIVITY:	ON-HIGHWAY	INCIDENT No:	00402

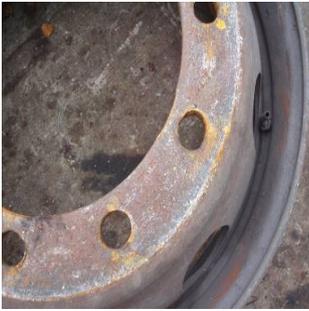
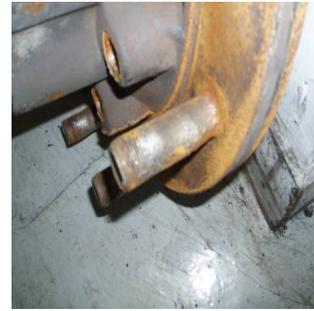
Recently, an articulated lorry lost a wheel on the M45 motorway. The driver felt the steering go slightly sloppy, so started to slow down; however the rev counter shot up even though he was decelerating. After travelling less than 1 mile from the initial suspected fault, the driver pulled over on to the hard shoulder, stopped the vehicle and climbed out of the cab once he had established that it was safe to do so. At this point it was evident that the wheel on the near side drive axle was missing and the second wheel was sitting at an angle. The wheel nuts on the wheel hub had come away completely leaving the studs in place. The wheel was never found.

Following an independent analysis of the remaining wheel studs, the report is inconclusive. The likely cause is both stud stretching, caused by historical over tightening when wheels are changed or worked on, combined with corrosion between the two faces of the drive axle wheels.

- The driver carried out his pre-start checks - Do drivers meticulously check wheel nuts when they carry out their pre-start checks? Are they trained and aware what to look for? Are vehicle checks documented by drivers and monitored by line managers to ensure defects are repaired in a timely manner and any trends are identified?
- The driver also walked around the vehicle to check the basics whilst at a customer site – Do drivers utilise the time when at a delivery point to carry out general spot checks on their vehicle?
- There is a wheel re-torque procedure in place - Are there processes in place when a wheel/tyre is changed to ensure it is initially torqued correctly using a calibrated wrench and then re-torqued at the appropriate interval? Are these processes

followed?

- The facing plates are cleaned each time a wheel is removed – Is there a process in place to ensure that facing plates are cleaned every time a set of wheels is worked on.
- The vehicle was fitted with wheel nut movement indicators – It is a company requirement that wheel nut movement indicators are fitted to LGV wheels to compliment, rather than replace, robust maintenance programmes.
