Fatal 5 - A loaded trailer uncouples and nearly causes a serious or fatal injury to operator - captured on a dramatic video

LOCATION:	CONSTRUCTION/DELIVERY SITE	ALERT STATUS:	Normal
ACTIVITY:	TRANSPORT & LOGISTICS / DELIVERY	DATE ISSUED:	27/11/2024 19:29:26
SUB ACTIVITY:	DELIVERING CONCRETE PRODUCTS	INCIDENT No:	04846

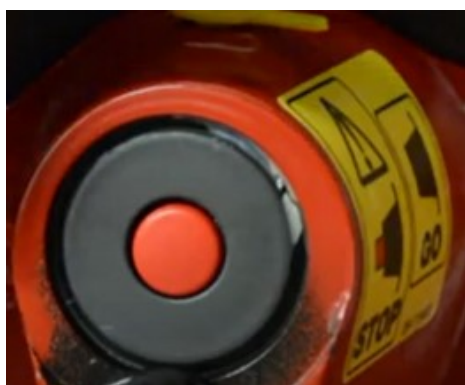
- The likely cause was the red safety interlock not being engaged correctly, causing the pin to work its way loose.
- A similar issue was previously identified by a competitor, who found that operating the vehicle with the coupling in the open position allowed dirt and debris to prevent the interlock from closing.
- Ensuring drivers are correctly trained in coupling and uncoupling, and the importance of the safety interlock being engaged.
- Considering a 10 weekly independent inspection of the coupling equipment or following the manufacturer's recommendations.
- Available technology in the cab can warn the driver if the coupling is open, including audible alarms.

Maintaining a Drawbar coupling involves several key principles to ensure its longevity and safe operation:

- Regular cleaning and lubrication: Clean and lubricate the coupling weekly. This helps prevent wear and tear and ensures smooth operation.
- Visual Inspections: Ensure daily visual inspections to check for deformations, cracks, or other damage. Pay special attention to the locking pin, drawbar, drawbar eye, drawbeam, endplates and guiding funnel. Follow the manufacturer's guidelines.
- Wear Measurements: Regularly measure wear on the coupling equipment, including the bolt dimensions and wear plates. Use equipment such as wear gauges to ensure dimensions remain within the manufacturer's specified limits.
- Functional Checks: Test the locking pin function and ensure it operates correctly. For remote-controlled couplings, check the indicator lights in the cab (red/open, green/ closed)
