TRANSPORT - Reversing vehicles and pedestrians - A reversing vehicle nearly collided with a driver

LOCATION: READYMIX OR MORTAR PLANT
ACTIVITY: PEDESTRIAN AND TRANSPORT SAFETY ON-SITE
SUB ACTIVITY: NO SUB ACTIVITY AVAILABLE

ALERT STATUS: Normal
DATE ISSUED: 11/09/2025 12:08:27
INCIDENT No: 04924

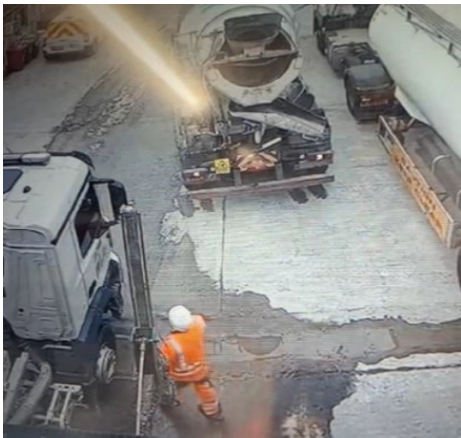
Image 1 - Driver of mixer truck being loaded approaches his cab as the other truck mixer reverses into parking position.

- Review site traffic management; are parking areas away from operational activities.
- Consider maximum numbers of vehicles allowed on site. If busy where can vehicles park up awaiting to be called forward to site.
- Stop work/production where traffic congestion is increasing risk.

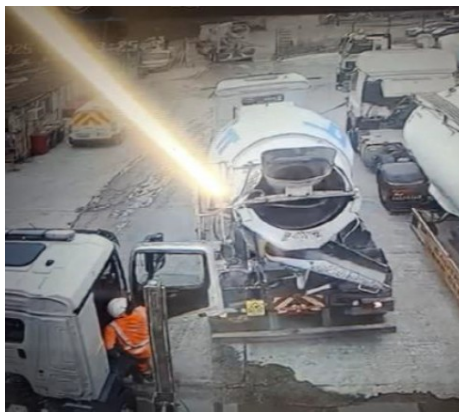
Image 2 - Driver begins to access his cab and then realises how close the reversing mixer truck is coming.

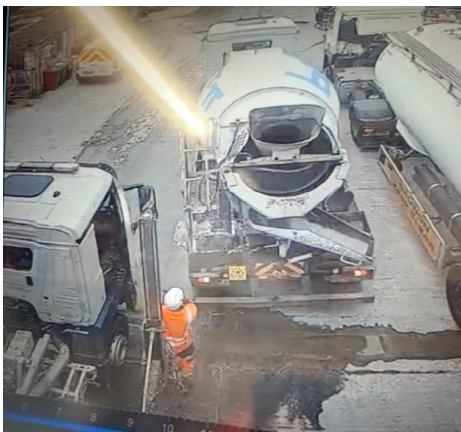
Image 3 - Driver dismounts and begins to move away as mixer truck comes very close to him.
