EYE INJURY - Foreign body scratches a fitter's eye whilst angle grinding

LOCATION:	COMPANY-WIDE	ALERT STATUS:	Normal
ACTIVITY:	POWER TOOLS AND BATTERY SAFETY	DATE ISSUED:	07/10/2025 21:04:34
SUB ACTIVITY:	NO SUB ACTIVITY AVAILABLE	INCIDENT No:	04936

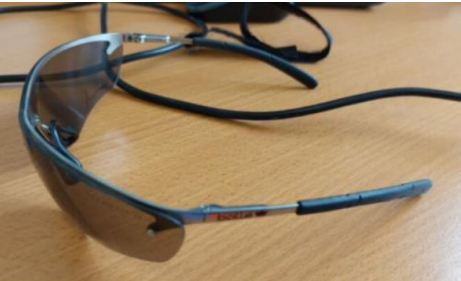
This image below shows an example of inappropriate eye protection; it does not seal the eye to prevent materials from entering the eye.

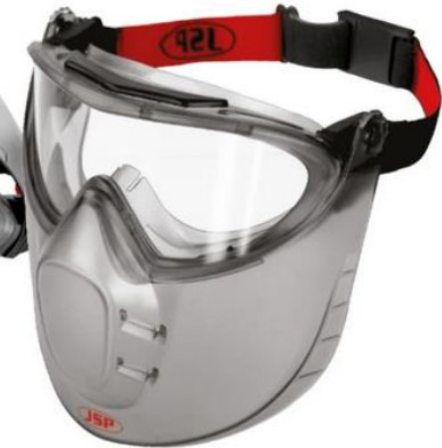
An example of suitable eye/face protection when using an angle grinder that allows the use of a hard hat.

- Risk assessments must encompass every step of an activity on that day. Walk and talk the activity through in its entirety to ensure all the hazards are identified and suitable controls are agreed and in place.
- Share the information contained in this link to the HSE's guidance on using the right type of PPR <https://www.hse.gov.uk/ppe/using-the-right-type-of-ppe.htm>
- Store PPE such that it cannot be easily damaged (e.g. scratched visor), it is protected and easily accessible.
