LOCATION:	Readymix or mortar plant	ARTICLE YEAR	2019
ACTIVITY:	Maintenance & Housekeeping	COMPANY:	Marshall's
SUB ACTIVITY:	N/A	COMPANY LOCATION:	Marshall's Premier Mortars and Screeds
BEST PRACTICE No:	BP2065	COMPANY TEL:	0000
COUNTRY OF ORIGIN:

**POD truck cleaning project - WINNER**

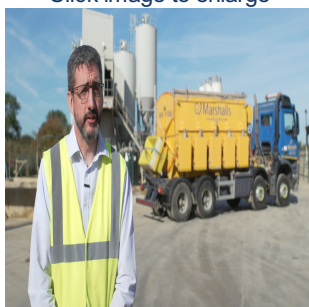
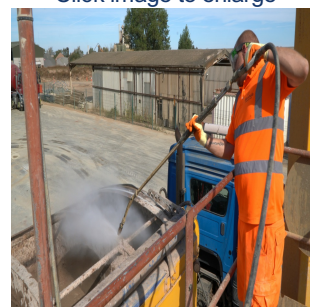
- A flexible scraper that contacted the walls was added to paddles; this significantly reduced the amount of mortar left sticking to the sides. All POD vehicles have had a standardised version of this modification installed.
- An adjustable pressure washer was fitted with turbo nozzles. The POD vehicle is moved alongside a gantry, an operator using the pressure washer is then able to clean the POD vehicles from above. The nozzle can be rotated to enable the operator to clean the nearside of the vehicle without it being re-positioned.
