BEST PRACTICE

Quarry
Worker Involvement
SSOW
BP2080

2019
Hanson Aggregates
Needingworth Quarry
0000

Bespoke moveable stop signs

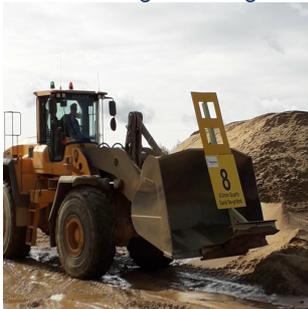
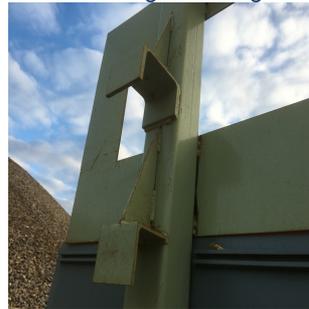
The sign can be lifted and placed into position by using a unique design that matches the measurements of the loading shovel buckets. It is picked up by placing the top lip of the loading shovel bucket in a bespoke notch welded to the upright and the bottom lip of the bucket into the lower angle of the bottom part of the base cross.

The numerical signs were cut from flat steel and painted to match the site QA dockets. The signs were placed on to the upright of a steel cross base.
