| ACTIVITY: | Access & Egress & Working at Height | COMPANY: | Aggregate Industries |
| BEST PRACTICE No: | BP365 | COMPANY TEL: | 07802 276 158 |

**CCTV cameras reduce tipper overturns**

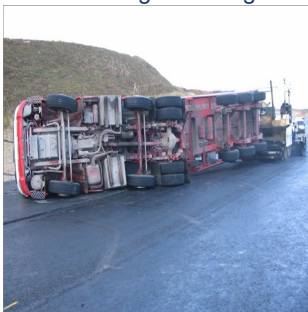
**vehicle tipping**

One of the difficulties associated with the transportation and tipping of heavy loads is the overturning of articulated tippers. In an attempt to prevent overturns, Bardon Aggregates installed CCTV cameras in the front-inside of the vehicle body. The image is then relayed to a monitor in the cab. The driver can now observe, visually, the loading and discharging operations from the safety of the vehicle cab, assessing if there is likely to be any danger of the lorry tipping.

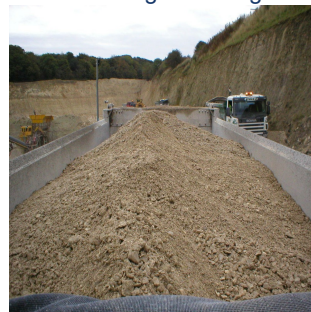
**cctv image**
