## BEST PRACTICE

LOCATION: Readymix or mortar plant  
ACTIVITY: Maintenance & Housekeeping  
SUB ACTIVITY: N/A  
BEST PRACTICE No: BP760  
COUNTRY OF ORIGIN: United Kingdom

<b>New tool to remove drive chamber insert from from mortar plant</b>	
<b>ARTICLE</b>	
<p>Description</p> <p>The removal of the dry chamber insert, which is the metal disk at the end of the chamber of a dry mortar mixing unit, took engineers around ten minutes. The task required the use of a hammer and nail to free the insert. This was very strenuous, time consuming and resulted in a near miss.</p> <p>Following this incident, a tool was developed by one of the engineers - a dry chamber insert extracting tool. The tool is simple to use and eliminates the need for any other tools. Utilising the motor of the silo, the insert can be removed in under a minute.</p> <p>Benefit</p> <p>The new system significantly reduces maintenance time and eliminates a potentially hazardous job.</p>	
<b>ARTICLE IMAGES</b>	
<p>Click image to enlarge</p>

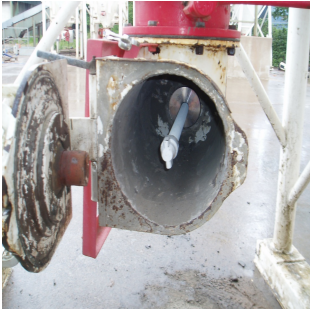
<p>New method</p>
