# Necessity to harness customer feedback the user's view

Troy Felts  
Head of Health and Safety  
Hanson UK

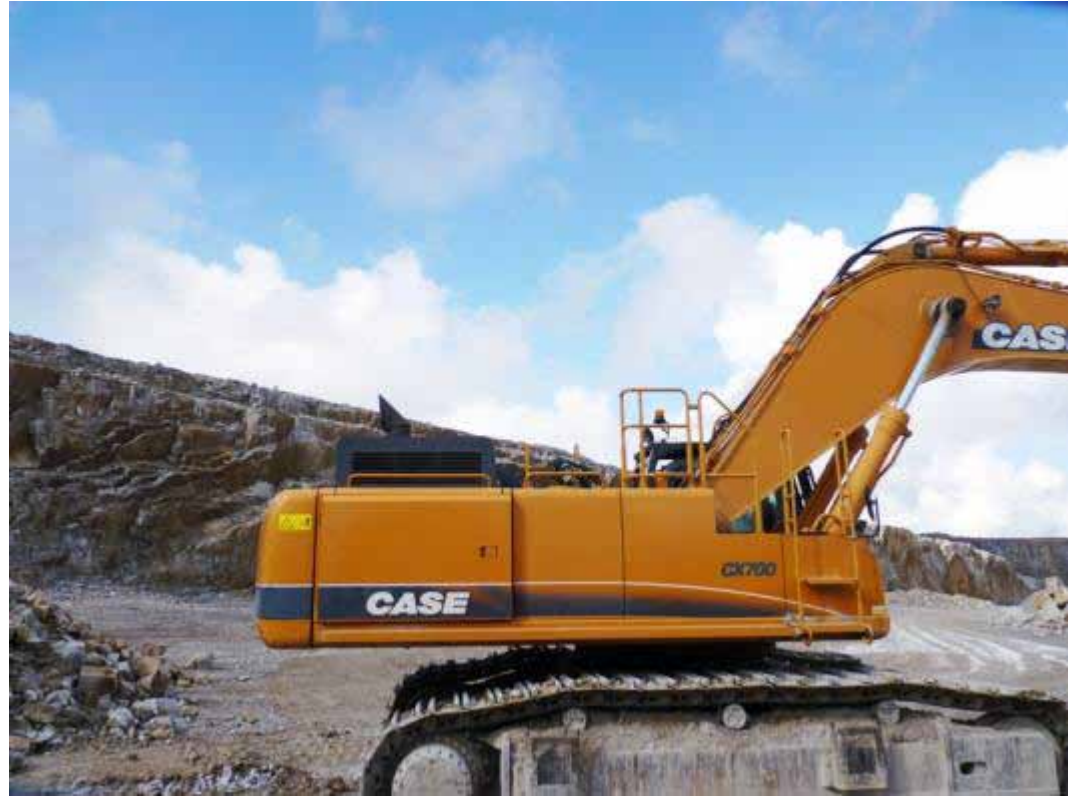
- n **Access to inspection points and risks from working at height with no protection**
- n **Would the OEM access provided on this machine satisfy the requirements of the working at heights directive?**
- n **Is fall protection adequately provided for?**
- n **Who will be held accountable for a life threatening head injury to an employee?**

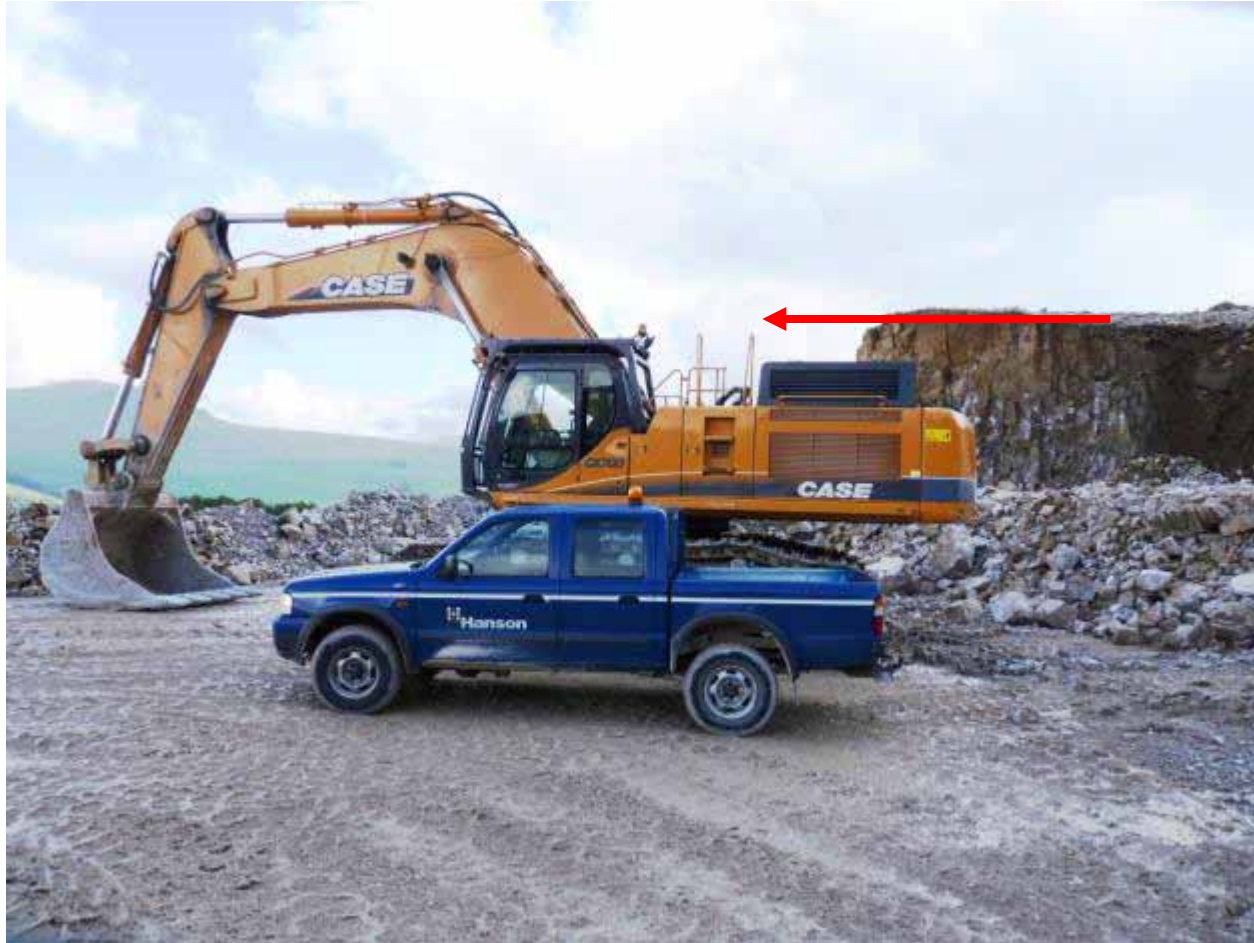
The pick up truck stands 1.8 metres to the roof, how high does this make the top of the access ladder?

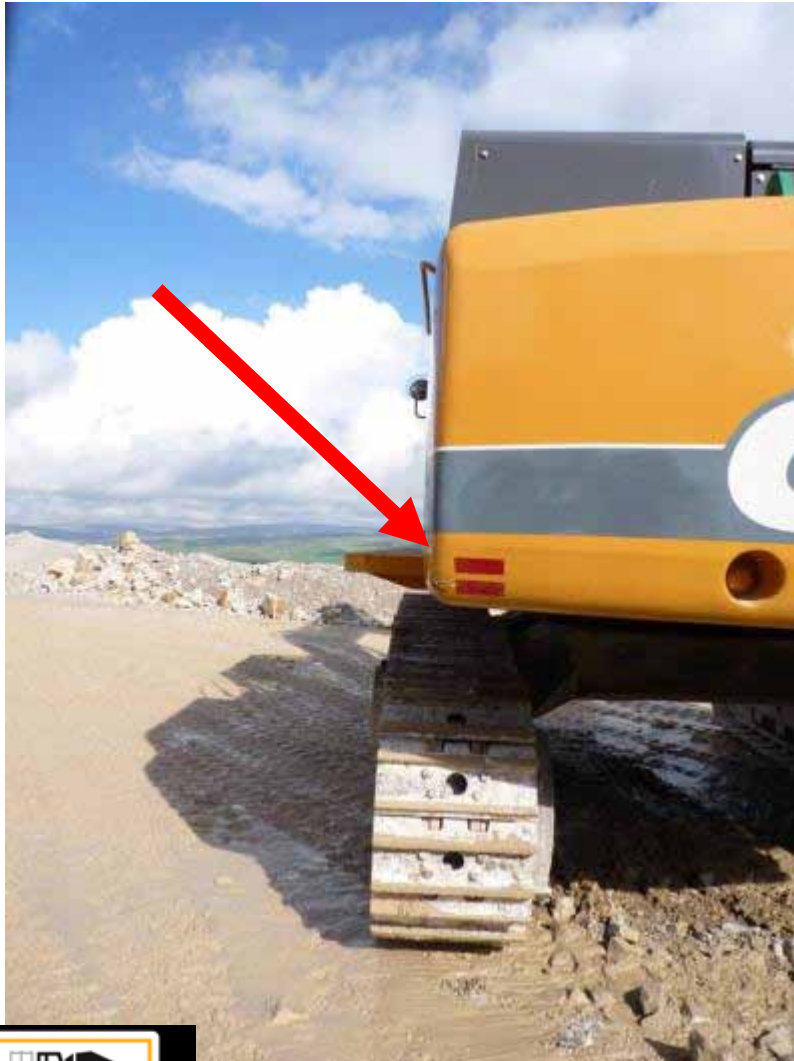
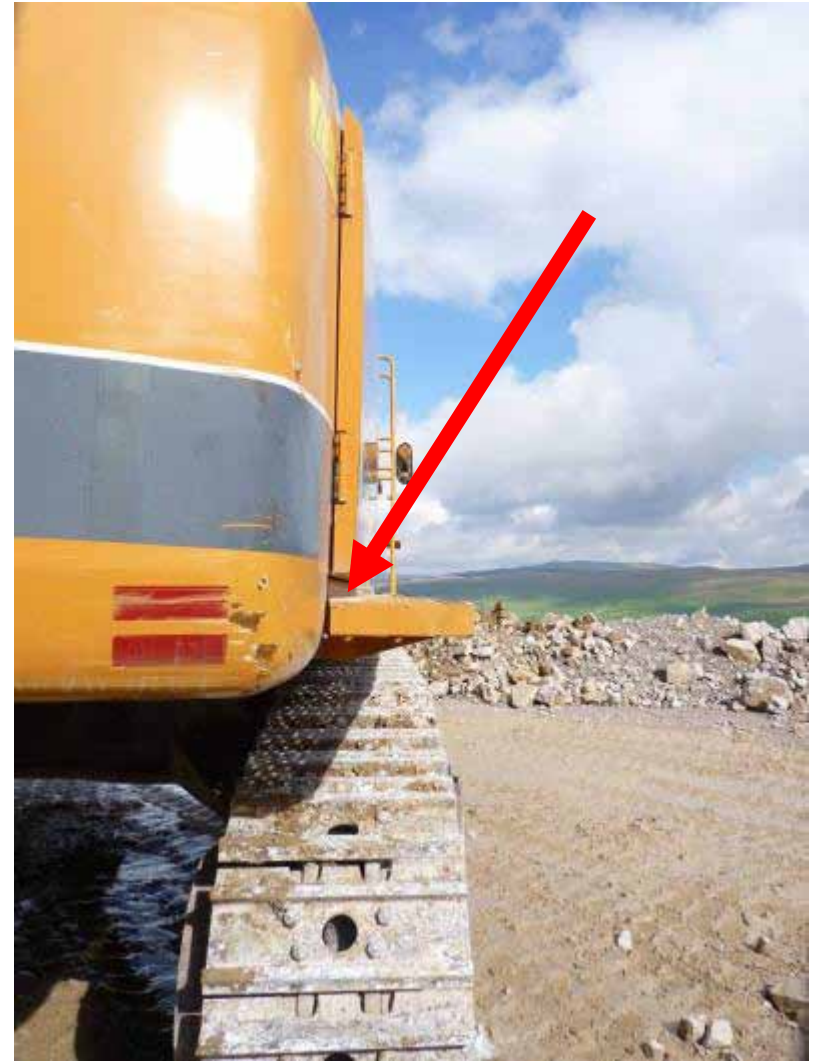
# What prevents the operator from falling off these walkways?

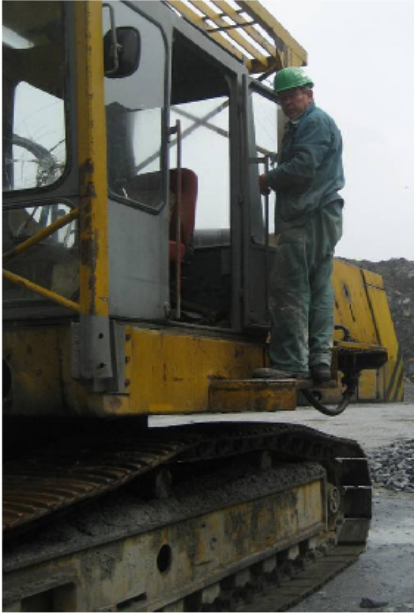
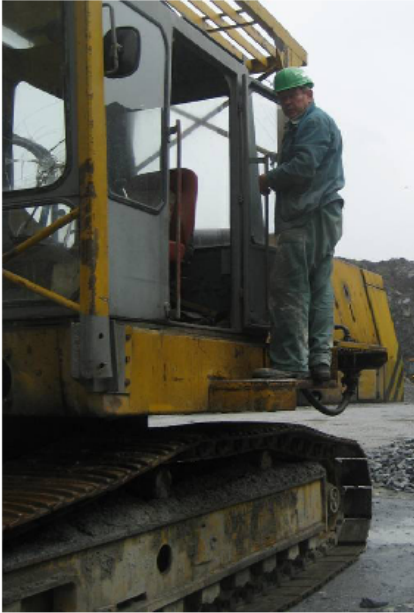
HC AID No:	226		
Business Line:	Aggregates		
Company/ Plant/ Country:	Českomoravský šternk, a.s.	Ondřejovice	Czech Rep.
Date - Time:	2009.06.25. 11:30	Lost days:	more than 133 days
Status:	Own employee		
What happened:	While the employee was getting off the excavator (DH 611) on the platform in front of the cabin, he slipped, lost his balance and fell on the ground. He broke his right heel bone.

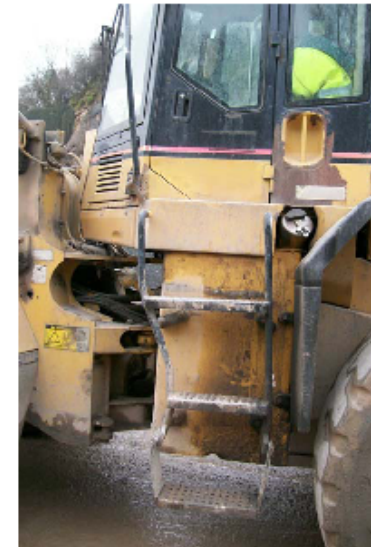
While leaving the cab of his loading shovel an operator jarred his back. He did not secure the door & also did not realise that the fixed handrail was wet causing him to lose balance & fall from the bottom step.

To ensure safe access & egress:

- Inspect steps & handrails
- Ensure that doors with handrails attached to them are safely secured
- Ensure steps & handrails are clean
- Always maintain 3 points of contact
- Be extra vigilant when entering or exiting mobile plant in wet or cold conditions

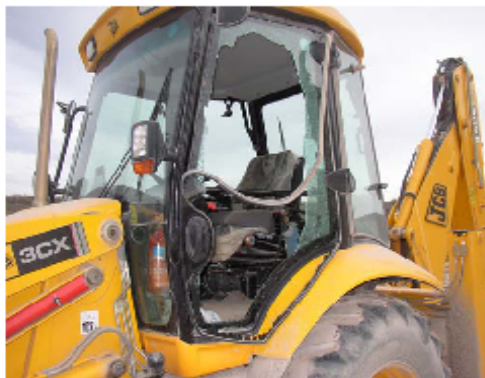
Shattered Glass Door Panel

The site operative dismantled from the JCB machine and shut the door using his left hand. The glass door panel shattered & some glass particles landed on the operatives hand causing some minor cuts. It appears the door latch punctured the glass panel as it struck the door.

The incident was reported to the JCB service provider, they claim that this is not a common fault with the latch and door. The door should have been fitted with a rubber block to prevent the latch striking the glass.

Glass replacement fitted by RAC.

- The latch is provided so the cab doors can be secured ajar whilst in operation.
- This machine is fitted with air-conditioning so there is no need for the additional ventilation.
- Latching the door open also increases the ingress of hazardous dust.
- The door latches have been removed from this vehicle.

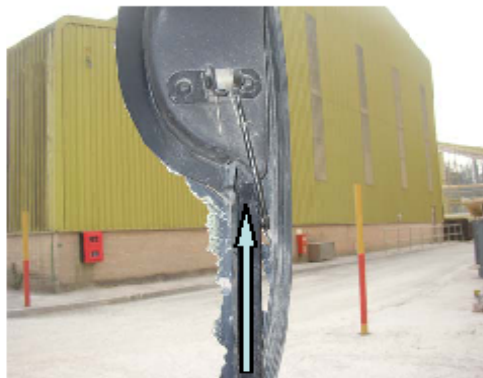
Door latch without rubber stop block

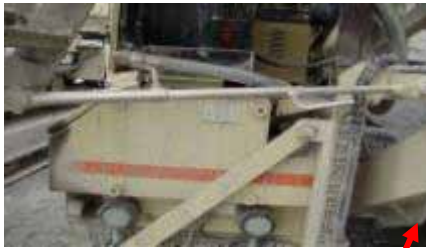
Following an incident involving the fixed steps on the Metso ST 300A mobile crusher, where the step adjuster locking mechanism had loosened due to vibration causing the steps to fold in when the operator attempted to climb on to the plant.

Original locking mechanism

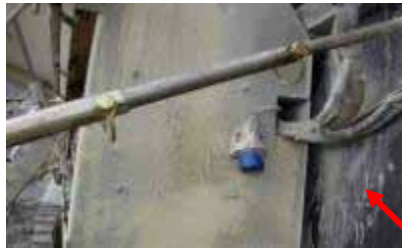
The locking mechanism has been redesigned to stop the possibility of loosening due to vibration.

Redesigned locking mechanism
