SAFETY ALERT #313

Title: COMPRESSED AIR CONNECTIONS

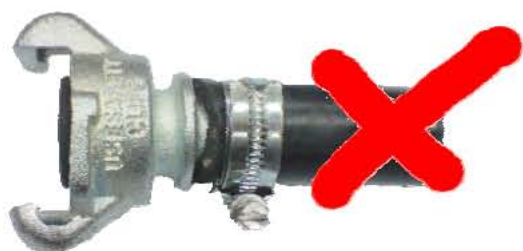
OLDER TYPE FITTINGS CAN BECOME LOOSE

The 'double clamp' fitting shown is a safer alternative to the older style fitting on the left picture above and consideration should be given to its use.

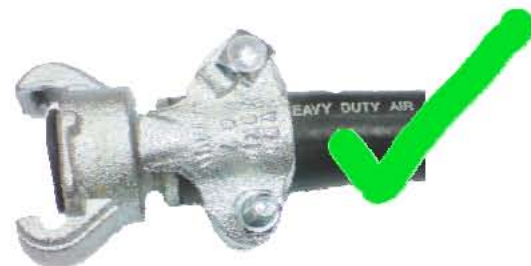
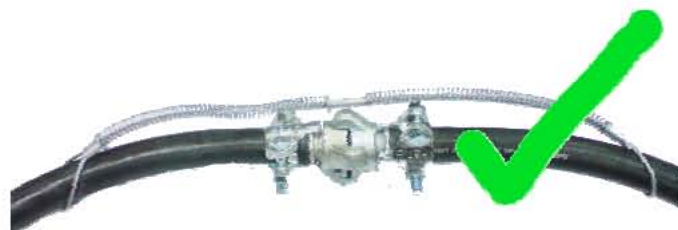
NEW FITTING ATTACHED TO HOSE & COUPLER WITH WHIP CHECK EXTENDED TO FULL LENGTH
