21149 **FMC Safer bitumen tank repair****FM Conway** **5**

**DESCRIPTION**

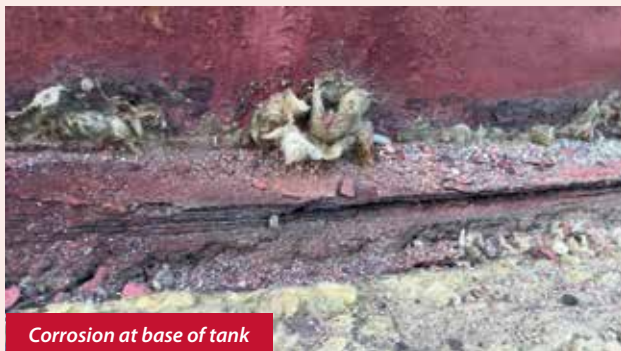
At FM Conway's Imperial Bitumen Terminal on the River Thames, Gravesend, bitumen is delivered into a series of tanks for storage and blending. The two largest tanks are 18m in diameter and 18m high and have a capacity of 3,000 tons of bitumen. These tanks are over 75 years old. As a result of corrosion, large portions of the base and sides up to 1m from the ground needed to be replaced with new steel plates 12mm thick.

**Corrosion at base of tank**

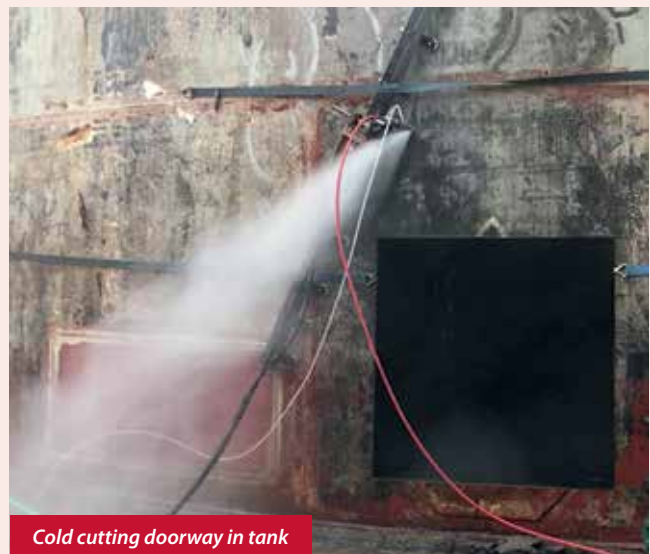
Rather than use a manhole hatch as the means of entry to the tank, a full height doorway was cut into the side of the tank to de-risk the confined space work required and to facilitate the easy removal of materials.

As the risk of fire or explosion was high before the inside was cleaned, it was necessary to cold cut the doorway. An accurate cold cut was made using high pressure water with a fine crushed garnet added into the flow.

Cold cutting doorway in tank

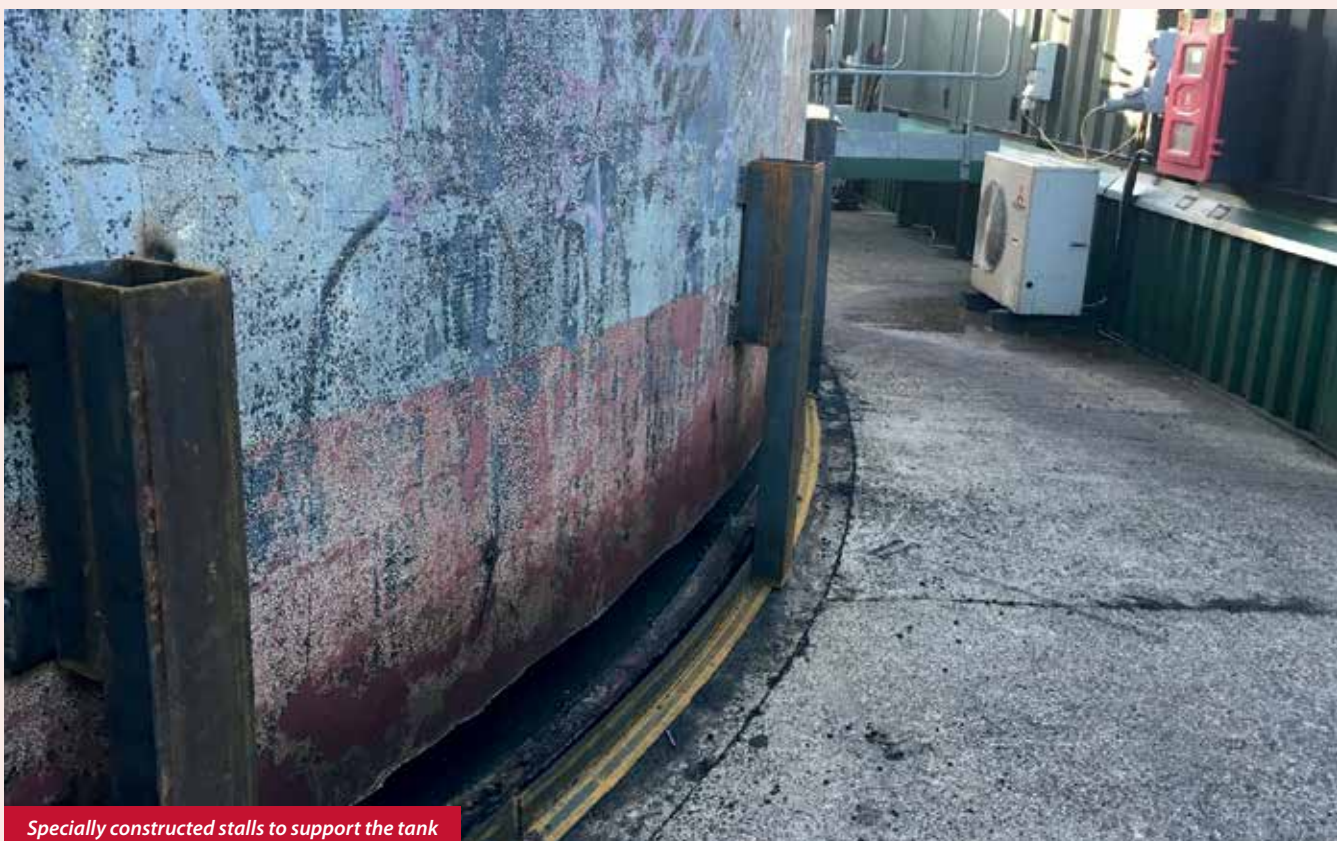
It was decided that the tank would be supported on specially designed stools whilst the bottom section was cut from it. The tank was free standing whilst the floor was replaced and then the sides were removed in 4m sections and new sections welded into place.

Specially constructed stalls to support the tank
