UK Safety Alert

Contractor Struck by Falling Cage

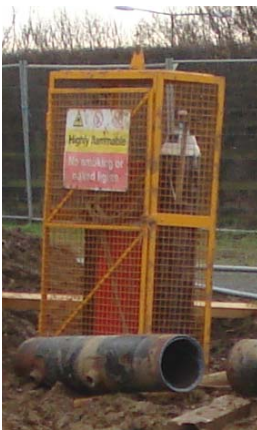
Gas Bottle Cage

- **Design – The cage had a height to width ratio of 3.4:1 and whilst it may have been fairly stable on a level hard surface, this would not be the case on any slight slope or uneven ground.** The cage should have been made secure or a different type of cage used, more suited to the ground conditions. Another option may have been to use a mobile cutting/welding unit. Is the suitability of equipment taken into account for tasks? Are alternatives considered to suit the conditions?

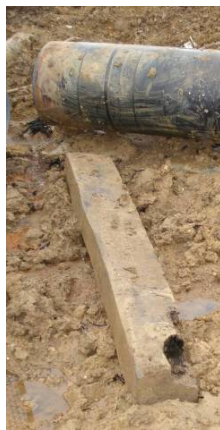
One of the wooden batons

The risk of the cage falling over had been identified and led to the decision to use the wooden batons to provide a stable base. However, the ground conditions had not been fully taken into account and the batons settled in the mud causing the cage to tilt and fall.

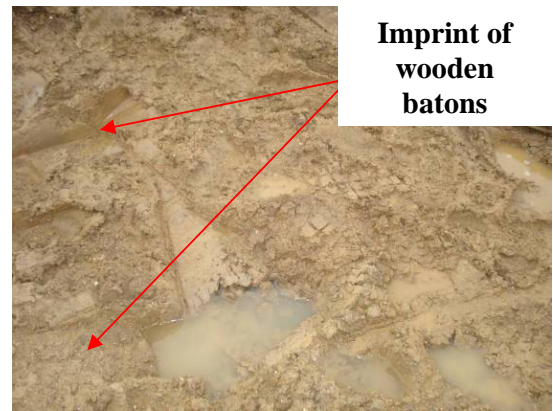
General ground conditions showing the imprint of the wooden batons

- **Risk Assessment – Whilst the task that was going to be performed (the cutting and welding of a pipeline) had been risk assessed and a method statement prepared, the setting up of the work area was not formally assessed.** Do risk assessments cover the preparation for a task as well as the actual task itself? Do risk assessments take into account weather/ground conditions?
