UK Safety Alert

Fall into Unguarded Opening Results in Injuries

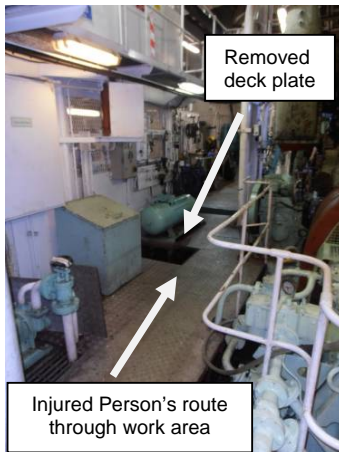
The Engineer who was fault finding briefly went below the removed deck plate to trace an air line. The Injured Person, who had completed his task, was returning his tools to the engine room workshop, via the area where the deck plate had been removed. The Engineer who had been below the plates for about a minute then climbed out and turned to see the IP carrying the tools approaching him and the unguarded opening in the deck. The Engineer immediately challenged the approaching IP by putting his hand up to warn / stop him from proceeding towards the hazardous location where the plate had been removed (Note: ear protection was being worn in the engine room). Unfortunately the IP failed to acknowledge the warning, as he was not looking where he was going, and subsequently stepped into the unguarded opening, falling to the deck; he did manage to stop himself from falling completely into the opening. This resulted in the IP requiring hospital treatment, where he was treated for fractures to his lower right leg and cuts and bruising to his left leg and arm.

Incident location

This incident demonstrates the importance of **always** putting physical barriers / guarding in place, with appropriate warning signage, prior to any plates, gratings or covers etc. being removed where there is a potential risk of falling into an unprotected opening, **even for short periods**. We all need to **STOP & THINK** about how our actions or inaction may affect the safety of others.

- While the Engineer was only under the plates for a very short period and did not leave the work location, he failed to look after himself and his colleagues by effectively physically guarding the work area and having the appropriate signage in place warning of the hazards at that location (E.G. "NO UNAUTHORISED ACCESS - FLOORING REMOVED").
- The contractors working alongside did not challenge the Engineer when he removed the deck plate about the lack of guarding around the opening.
- The Injured Person knowingly went into a work area when there was another alternative safe route available.
- The Injured Person wasn't looking where he was going when he was transiting the known work area.

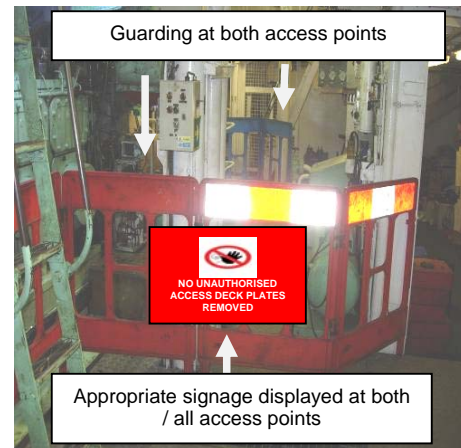
What should have been in Place - Always guard openings
