SAFETY ALERT

Fatal Incident – Member of Public

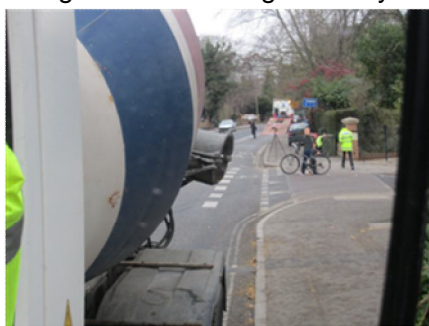
Mirror view showing cyclist

It was commented by the Police that the kerbside close proximity mirror was incorrectly aligned. Do drivers know how to check and adjust their mirrors so that they are correctly aligned?

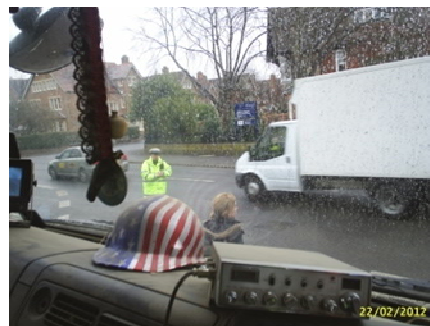
Items obscuring vision

There were a number of items obstructing forward vision and view of the mirrors from the driver’s position. Are drivers aware of the need to ensure their field of vision and view of their mirrors is maximised to reduce the potential for ‘blind spots’ around their vehicles?

Housekeeping inside the cab was poor, with debris and equipment stored in the passenger foot well. Are the cabs of vehicles kept clean, with all items secured, to ensure nothing interferes with their safe operation, or causes injury in the event of a collision?
