21034

Newark VPMP project

Tarmac Building Products > Newark Aggregate Blocks**1 2 6**

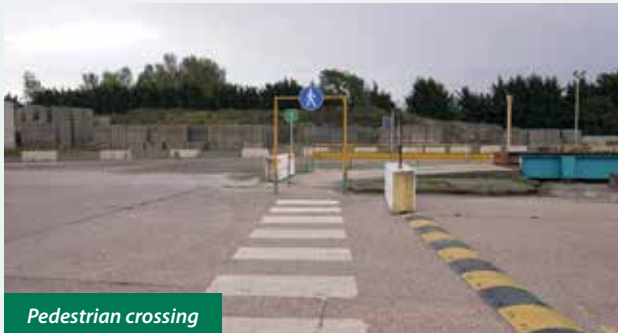
**Pedestrian crossing**

- Risk of pedestrians being struck by vehicles significantly reduced
- Risk of collisions between vehicles considerably reduced
- Pedestrian crossings reduced from 3 to 1.

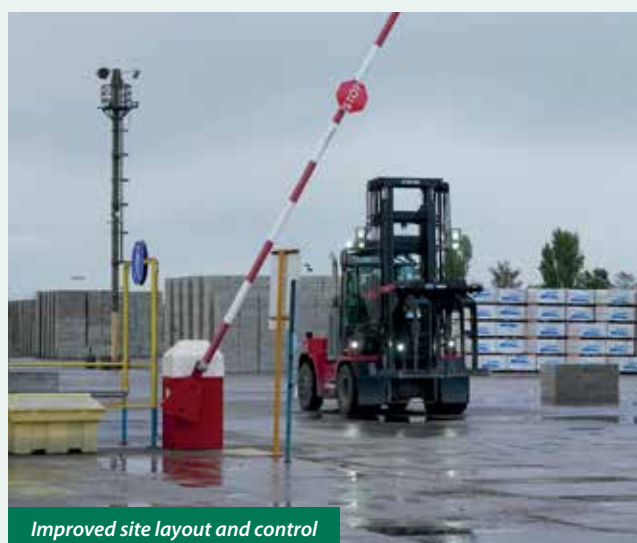
Improved site layout and control

- The car park was relocated to the other side of the site entrance
- Concrete block system was introduced to car park to improve protection
- The old car park was converted into a designated waiting area separate from live traffic routes

- A control gate was installed at the entrance to the aggregate yard controlled by the shovel driver.
- The loading area was relocated away from the production take-off point

- Clamp trucks upgraded from 2 to 4 packs to improve efficiency of loading
- A control barrier was installed at the entrance to the loading area
- Designated loading bays were introduced to the VPMP, and lines painted onto the yard

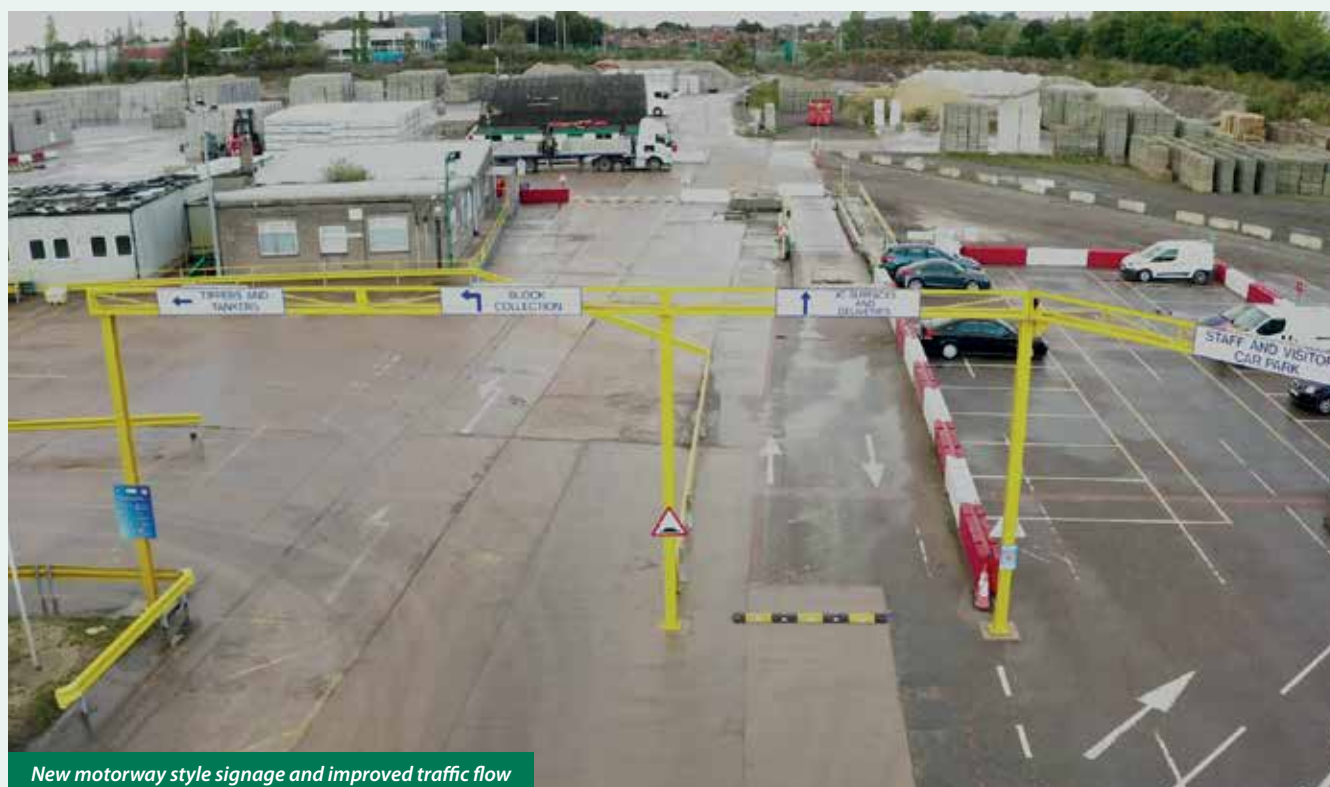
New motorway style signage and improved traffic flow

- The two-way system was converted into a one-way traffic system
- The new route was clearly signposted as "Tipper and Tanker Lane" using motorway-style signs

- Clamp truck drivers were given control over their own area
- Signage updated across site including the introduction of some motorway-style
- Leaflet and briefing provided to employees on the site changes
