2012 Health & Safety Awards

Entrant Company:	Aggregate Industries – Concrete Products
Entrant Contact Name:	Ian Sherratt - Site Manager
Site Name:	Leighton Buzzard
Project Name:	Occupational dust reduction
Address:	Charcon Leighton Buzzard Grovebury Road Leighton Buzzard LU7 4RU
Tel:	01525 382576
Fax:	01525 383070
Email:	Ian.sherratt@aggregate.com
Senior Manager Signature:	P. A. Jose 15/3/12
Date:	15/3/12

Occupational Health - Resume

Leighton Buzzard site - Rumbler

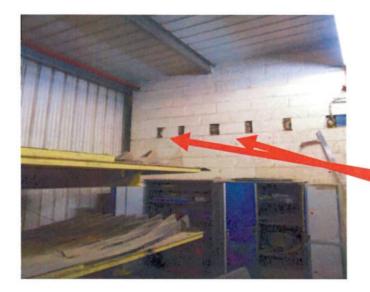
Wall separating
Rumbler drum and
working area. There
were multiple points
where dust was able to
enter the working area

The sealing of all areas in the dividing wall between the Rumbler drum and the sorting stations using expanding foam, physical barriers made using plywood and sealing strips and repositioning of the existing extraction ducts.

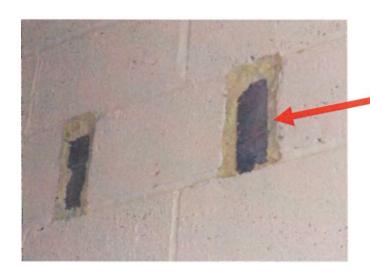
Holes in wall sealed off using expanding foam and bricks

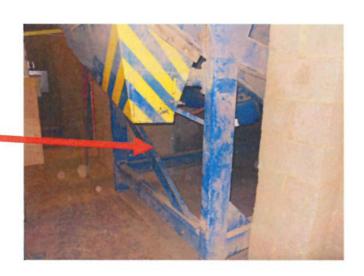
Dust entry point into working area

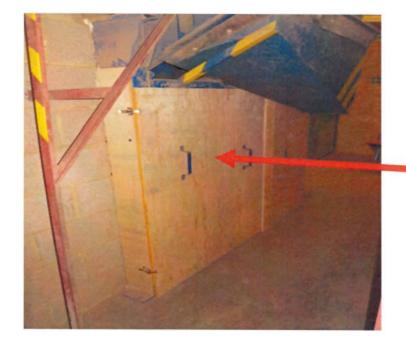
Wooden covers with rubber seals used to prevent dust transferring into working area

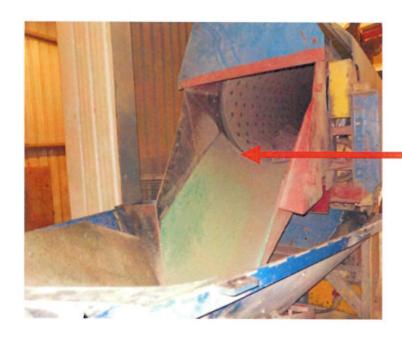
Exit from Rumbler drum open – extraction unit unable to draw dust away thus allowing to enter the atmosphere

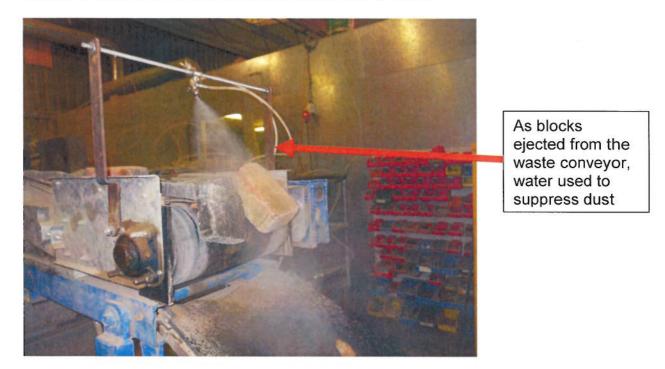
It was noted that when the reject conveyor was activated, the blocks when falling off the conveyor into the waste skip generated small clouds of dust. A trial was carried out where the blocks were sprayed with water using a garden sprayer to see if it suppressed the dust. Results were very good. As a result a spray bar taken from a redundant piece of equipment was fitted. Now, as soon as the reject conveyor is activated, the water sprayer is activated and a water mist suppresses the dust.

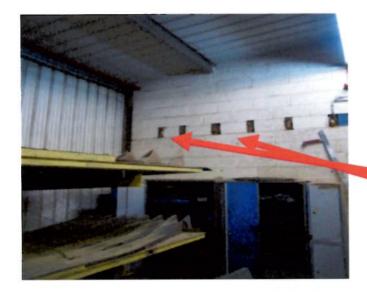
Wall separating Rumbler drum and working area. There were multiple points where dust was able to enter the working area

The sealing of all areas in the dividing wall between the Rumbler drum and the sorting stations using expanding foam, physical barriers made using plywood and sealing strips and repositioning of the existing extraction ducts.

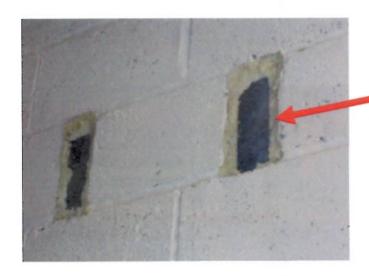
Holes in wall sealed off using expanding foam and bricks

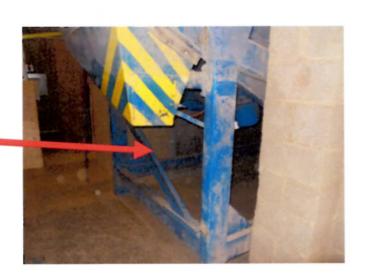
Dust entry point into working area

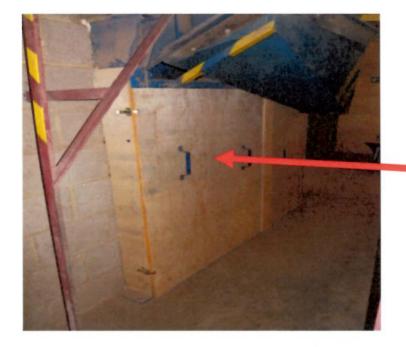
Wooden covers with rubber seals used to prevent dust transferring into working area

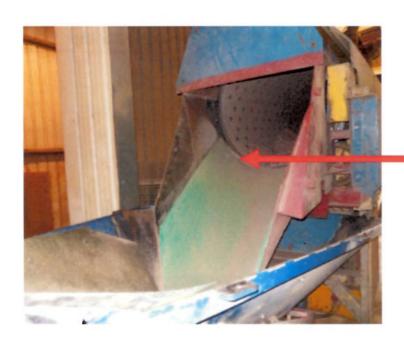
Exit from Rumbler drum open – extraction unit unable to draw dust away thus allowing to enter the atmosphere

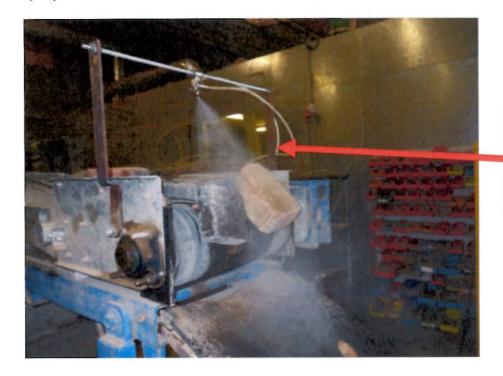
As blocks ejected from the waste conveyor, water used to suppress dust

It was noted that when the reject conveyor was activated, the blocks when falling off the conveyor into the waste skip generated small clouds of dust. A trial was carried out where the blocks were sprayed with water using a garden sprayer to see if it suppressed the dust. Results were very good. As a result a spray bar taken from a redundant piece of equipment was fitted. Now, as soon as the reject conveyor is activated, the water sprayer is activated and a water mist suppresses the dust.
