Fatal 1 - Failure to properly isolate agitators at block plant during maintenance work

LOCATION:	**CONCRETE PRODUCTS PLANT**	**ALERT STATUS:**	**Normal**
ACTIVITY:	**GUARDING AND ISOLATION**	**DATE ISSUED:**	**22/06/2023 12:47:56**
SUB ACTIVITY:	**NO SUB ACTIVITY AVAILABLE**	**INCIDENT No:**	**03645**

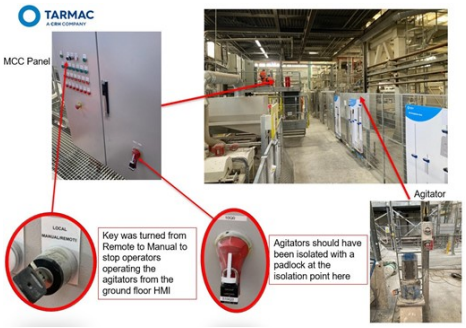
During a yearly shutdown in April 2022 at a block plant, work was planned to be carried out by the operators to dig out the vac crust pit located under the vac and cutting line. Operators had taken out the castell key to enter the vac area and put into the lock box. All the operators individually locked off to the box securing the area to work in, they then entered the area and began to dig out the crust pit. While carrying out a walk of the area, a safety rep and maintenance manager identified the agitators within the area were switched off (To “Manual”) on the MCC panel on the mezzanine floor but the panel was not fully isolated, and no isolation document had been completed.

Although a LOTOTO SOP for this task was present and clear, including all the isolation points, the responsible person had failed to own the isolation process and to make sure all the measures were in place before the work commenced.

- Share this incident with all sites
- Review site isolation process and training in line with company standard, and site shut down procedure.
- Find engineering solutions to simplify the isolation process in line with best practice.
