Fatal 5 - Dump truck hits van in incident that could have been fatal.

Potential Fatal Incident (PFI) - Ongoing investigation

LOCATION:	**QUARRY**	**ALERT STATUS:**	**Normal**
ACTIVITY:	**MOBILE PLANT OPERATION AND MAINTENANCE**	**DATE ISSUED:**	**20/11/2025 11:30:15**
SUB ACTIVITY:	**NO SUB ACTIVITY AVAILABLE**	**INCIDENT No:**	**04947**

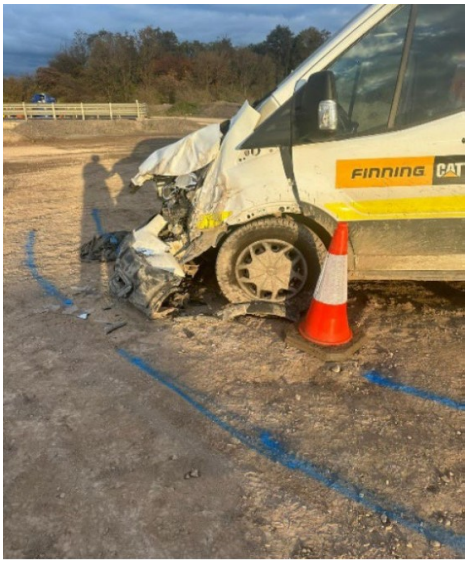
A potentially fatal incident occurred recently at a quarry within a mobile plant compound.

A Finning's engineer was working on a CAT 777, carrying out a maintenance task. The machine had been de-isolated so the fitter could test whether it was ready to be put back into service. When the operator returned to the machine, they performed their walkaround and pre-start inspection.

This incident is still under investigation but it reinforces the importance of measures that help to warn drivers of the proximity of other vehicles and other measures that help to mitigate the risk of collisions.

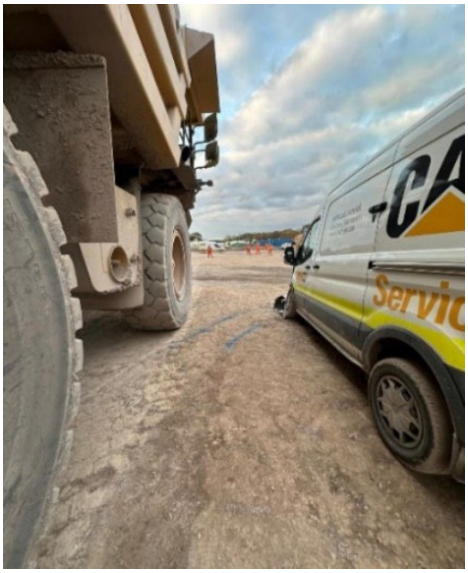
The engineer then returned to their van, which was parked approximately 1.5 to 2 meters from the dumper's blind side.

The operator then pulled forward, sharply turning right at the same time to avoid a front-end loader (FEL) which was stationary 15 meters ahead. In doing so, the back wheel made contact with the front passenger side of the engineer's van. The operator was unaware of the collision and continued to the extraction area before being called back via radio.

The engineer was sat in the driver's seat of the van and did not sustain any injuries.
