TRANSPORT – FATAL 6 – Tipper rollover on M4

LOCATION:	**ON-HIGHWAY**	**ALERT STATUS:**	**Normal**
ACTIVITY:	**TRANSPORT & LOGISTICS / DELIVERY**	**DATE ISSUED:**	**11/06/2026 23:44:41**
SUB ACTIVITY:	**ROLLOVERS**	**INCIDENT No:**	**04978**

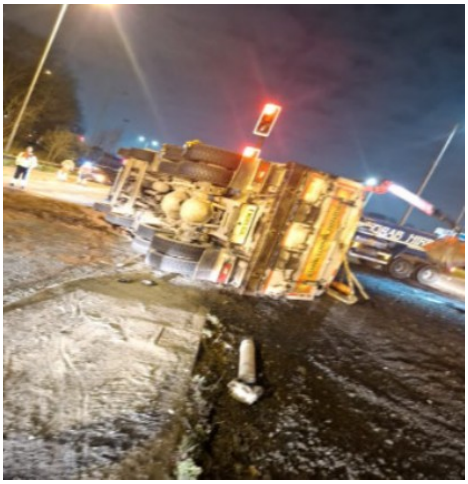
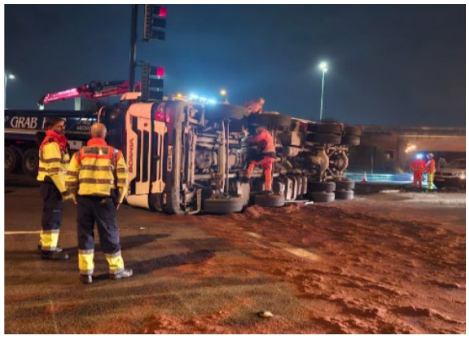
A loaded tipper lorry traveling in the early hours of the morning on the M4, overturned onto its side at Junction 4. The driver sustained minor injuries and there was a diesel spill to the highway. No other persons were involved or injured.

The following root causes were identified;

- The vehicle stability when carrying approximately three-quarters load of planings were not fully considered, increasing rollover risk during braking and steering.
- Speed was not reduced sufficiently early on approach to the bend.
- End-of-shift/night-time driving contributed to fatigue, reducing alertness, cognitive processing, and forward planning.
- Fatigue and perceived time pressure impacted decision-making.

Driver removed from the company's operations and a lifetime ban applied.

• Ensure drivers adjust their driving style and speed to suit the road and environmental conditions.

• Increased awareness of night-time driving risks.

• Reinforcement of the need for early speed reduction and forward planning when approaching motorway slip roads.

• Improved understanding of vehicle stability risks.

• Ensure sufficient breaks and rest periods are adhered to.
