Fatal 3 - Operators at risk of fall from height whilst working on roof of cement mill

LOCATION:	**CEMENT PLANT**	**ALERT STATUS:**	**Normal**
ACTIVITY:	**ACCESS & EGRESS & WORKING AT HEIGHT**	**DATE ISSUED:**	**16/11/2026 16:33:47**
SUB ACTIVITY:	**N/A**	**INCIDENT No:**	**04989**

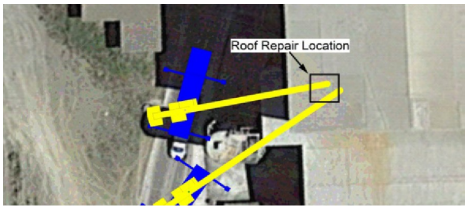
During roof repair work on the cement mill building, two contractor operatives were observed working at height. Both were wearing individual safety harnesses and lanyards, but both lanyard systems were connected to the same endless sling safety line. One of the two planned cranes could not reach the required roof corner, so both operatives used the remaining crane. The shared-line arrangement was identified, and the work was stopped immediately. The arrangement was reviewed and corrected before work continued.

- Inadequate planning and management control of the work at height activity
- Failure of the planning and management-of-change process to ensure that any deviation from the agreed work-at-height method was stopped, risk assessed and authorised before work continued.

The image below shows the location of the cranes and the area of the roof being worked on.

- For crane-supported work at height, verify all work locations against the planned crane positions, radius and access arrangements before work starts.
- Complete a joint pre-start review by the contractor, crane company and a company representative, including fall-protection and rescue arrangements.
- If the planned method cannot be followed because of crane reach, access or other unforeseen conditions, stop the activity, reassess the method and obtain formal approval before continuing.
- Each operative must have an independently suitable fall-protection connection unless the system is specifically designed, certified and approved for simultaneous multiple users.
- Brief relevant contractor and site teams on this event, with emphasis on crane working envelopes, point-of-work changes and maintaining independent fall protection.
