Fatal 6 - Return roller nip guard on conveyor falls 4m and hits contractor

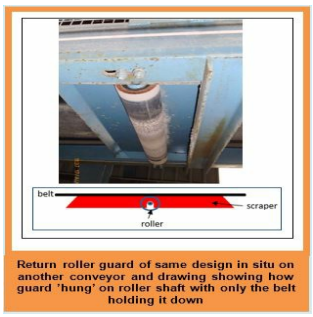
The contractor was standing under the incline conveyor belt system as he pulled the old conveyor belt through the system. During this operation an original return roller nip guard was dislodged. Investigation showed that it was designed so that it hung over the roller shaft and was only held in place by the belt and gravity.

The guard weighing circa 8kg fell 4m and hit the contractor on the centre of his hard hat. Fortunately, the contractor suffered only neck and muscle strain and was able to continue working after a short period.

Hard hat with dent along back near centre

Return roller guard of same design in situ on another conveyor and drawing showing how guard 'hung' on roller shaft with only the belt holding it down

- Check to see if this type of system is present on your site
- If they are on site, amend risk assessments / safe systems of work to include the need to check how roller nip guards, rollers and scrapers are secured
- Ensure all return roller nip guards, rollers and scrapers are securely fixed before any conveyor belt replacement work commences
- Any person carrying out a task where objects or items above them could fall should wear a hard hat, not a bump hat.
- Exclusion zones should be set up in any area where equipment is being worked on overhead
