Slips, trips and falls –Individual sustains sprained wrist, cuts and grazes following a trip on pedestrian walkway

LOCATION:	**QUARRY**	**ALERT STATUS:**	**Normal**
ACTIVITY:	**PEDESTRIAN SAFETY**	**DATE ISSUED:**	**30/07/2023 20:36:00**
SUB ACTIVITY:	**NO SUB ACTIVITY AVAILABLE**	**INCIDENT No:**	**03655**

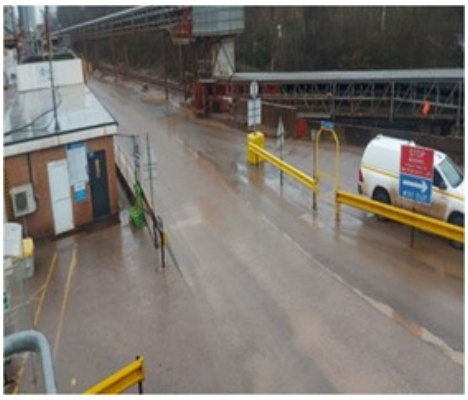
The IP was walking across the designated pedestrian walkway to the vehicle ‘pull up’ point outside the weighbridge to conduct inspection and inductions. The IP tripped on a slightly raised section of asphalt and fell forwards, in doing so they tried to break their fall by putting their hands out resulting in a sprained wrist, cuts and grazes to their hand, knees, and head.

- IP had not been inducted to site
- IP did not have a risk assessment for the task
- The raised level is historic and caused by an additional layer of asphalt added to the road

- Area to be levelled to remove the raised level
- Complete Hazard Identification Risk Assessment for task
- Review induction process on multi-unit sites
- Review pedestrian crossing to ensure direct crossing via additional designated gate
