Fatal 1 - Operator injured interacting with a trough roller

An operator's hand was lacerated when they attempted to remove a piece of aggregate

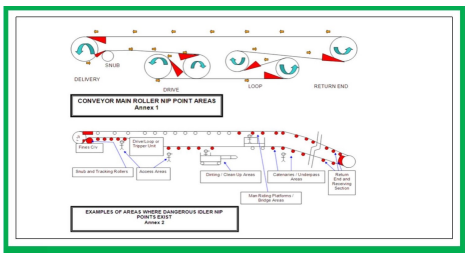
An operator suffered a laceration to his right hand when attempting to flick and remove a piece of aggregate from a moving trough roller on a feed belt. The site had experienced issues previously with the belt scoring and eventually splitting.

The IP was not wearing gloves and the plant was not isolated.

- Ensure you apply LOTOTO prior to interacting with any machinery. Never be tempted with "I'll just"….
- Review your risk assessments for conveyor safety and use a schematic as shown below to identify dangerous nip points.
