Fatal 1 - Operative working in guarded area without following LOTOTO procedure (bypassing safety system)

LOCATION:	**CONCRETE PRODUCTS PLANT**	**ALERT STATUS:**	**High Potential**
ACTIVITY:	**GUARDING AND ISOLATION**	**DATE ISSUED:**	**28/05/2024 16:23:18**
SUB ACTIVITY:	**NO SUB ACTIVITY AVAILABLE**	**INCIDENT No:**	**03711**

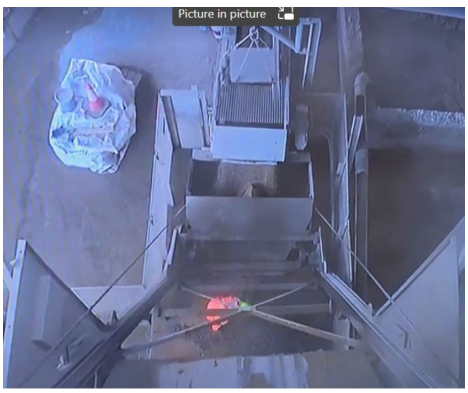
- Breaching UKCP62 Isolation and Lockout Procedure, and not following LOTOTO Training requirements.

Below is an image of the securely bolted hinged guard that was used to bypass the Castell key exchange gate.

- UK communications to be developed to share learnings
- Develop and roll out a UK wide safety video ‘I could have saved a life that day but chose to look the other way’
- Proposal for bolt heads to be welded so they can only be removed from inside the interlocked guarded area to be shared with the projects team
