Failure of tipper's sheeting arm whilst driving on motorway

LOCATION:	**ON-HIGHWAY**	**ALERT STATUS:**	**Normal**
ACTIVITY:	**TRANSPORT & LOGISTICS / DELIVERY**	**DATE ISSUED:**	**25/02/2015 00:30:20**
SUB ACTIVITY:	**ON-HIGHWAY**	**INCIDENT No:**	**00405**

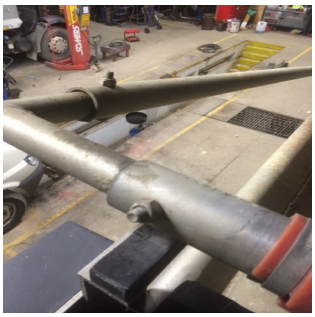
Figure 1

The bottom end of the sheeting arms and the attached springs are held on the mounting spigot by a large washer and split pin (see figure 1). The sheeting arms on either side of the body are joined together by a cross member bar which is attached by an elbow joint on either end (see figure21). The sheet/net is also attached to this cross member at one end and to a spindle at the headboard which is operated by the sheeting motor.

The offside end of the cross member sheared off at the elbow joint thus causing the offside sheeting arm to become detached from the cross member. As the arm was under tension from the spring, this caused the arm to swing towards the end of the trailer. In normal circumstances the complete mechanism would be released towards the rear of the trailer slowly as the sheet is fed out by the motor. It would then come to rest with a cross member located in the brackets at the top of the tailboard. As the offside sheeting arm was only attached to the trailer by the spigot it swung right down until the end of the arm hit the road.

refuge next to the hard shoulder. On inspection he immediately noticed that the sheeting arm had actually become detached from the mounting point and was on the carriageway. On later inspection it was discovered that the split pin had sheared and the retaining washer had fallen off.

Immediate:
All vehicle sheeting systems visually checked and drivers instructed to ensure sheet is in closed position when vehicle not in use. This will prevent the springs from being under prolonged tension and enable drivers to carry out more extensive checks.

Mid & long-term:
Discuss incident report, together with design and use procedures, with the system manufacturers. Investigate the fitting of side to side automatic sheeting systems on new vehicles.
