Quarry Contractors – Failure by a contractor to perform an earthmoving operation at a quarry safely - highlights responsibilities of company to manage contractors undertake the task safely

LOCATION:	**QUARRY**	**ALERT STATUS:**	**Normal**
ACTIVITY:	**QUARRYING AND FACE ACTIVITY**	**DATE ISSUED:**	**17/03/2025 15:04:13**
SUB ACTIVITY:	**NO SUB ACTIVITY AVAILABLE**	**INCIDENT No:**	**04862**

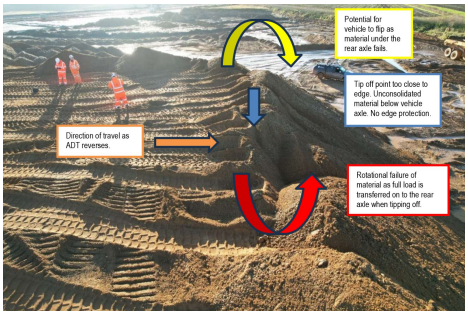
This action was taken because the following issues were identified:

- Non-compliance with the company's PPE policy – identified during VFL visit and subsequently not acted upon.
- Lack of notification to relevant Quarry Responsible Manager when accessing site.
- Failure to stockpile mineral as per design document, including:
    - Ensuring correct material compaction (to minimise geotechnical instability).
    - Excessive height of stockpile.
    - High risk end tipping activities. End tipping is forbidden on all the company sites.
    - Missing edge protection
    - Inaction following previous improvement request.

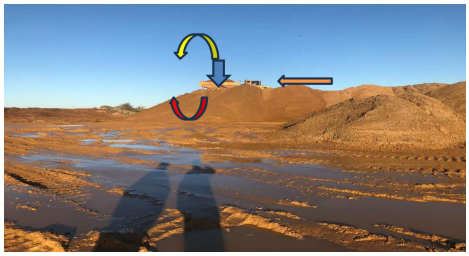
View from above the stockpiled material

Side view of the stockpiled mineral

The edge protection

- Please could all quarry responsible manager's ensure they reiterate the importance of these omissions to all relevant quarry colleagues including internal plant operatives and external contractors.
- Ensure that each site's appointed personnel is competent to advise on these risks in the context of safe operation of quarries in minimising geotechnical instability and unsafe acts.
- Please check the quarry's Excavation and Tipping Rules to ensure they are up to date and relevant to the site – requesting assistance from LMR where required.
- Even if the contractor supplies a floor-based supervisor, as an appointed person you need to be vigilant and ensure that you carry out your inspections and manage the contractors.
