TRANSPORT - Fatal 5 - Driver exposes himself to risk of serious injury whilst inflating a tyre on a vehicle

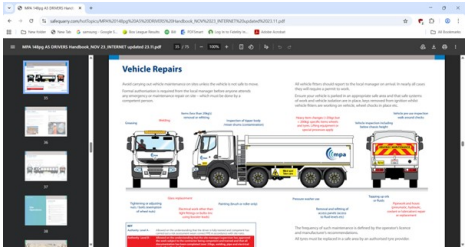
A franchise haulier's driver was seen underneath a raised tipper body with no body props, engine running, no RAMS or management approval, inflating a tyre with an airline that had no pressure gauge and without correct PPE. The driver's behaviour in failing to follow procedures had exposed himself to potential of sustaining a serious injury.

Note: The use of an airline with no inline pressure gauge could lead to over inflation and tyre explosion, a vehicle's typical tyre pressure is around 110psi, if exceeded, the tyre could explode. There are several incidents alerts on Safequarry where tyres have exploded whilst being inflated. Go to the incident alert section of Safequarry and add the word **tyre** to the **Keyword Search** to see examples.

- The PPE signs around the truck parking areas at the site would be improved.

- Tyre inflation and tyre defects are only to be carried out by trained/competent tyre fitter with RAMS/Management approval in place.
- Body Props are only to be used by trained/competent LGV fitters with RAMS/ Management approval in place.
- Consideration MUST aways be taken to identify and control all forms of stored energy in all tasks to be completed (see list of types of stored energy below)
