# A maintenance inspection of bitumen tank uncovers severe corrosion at base of tank

LOCATION:	ASPHALT/COATING PLANT
ACTIVITY:	MAINTENANCE & HOUSEKEEPING
SUB ACTIVITY:	ASPHALT & COATED STONE

ALERT STATUS:	High Potential
DATE ISSUED:	19/08/2024 15:45:04
INCIDENT No:	03729

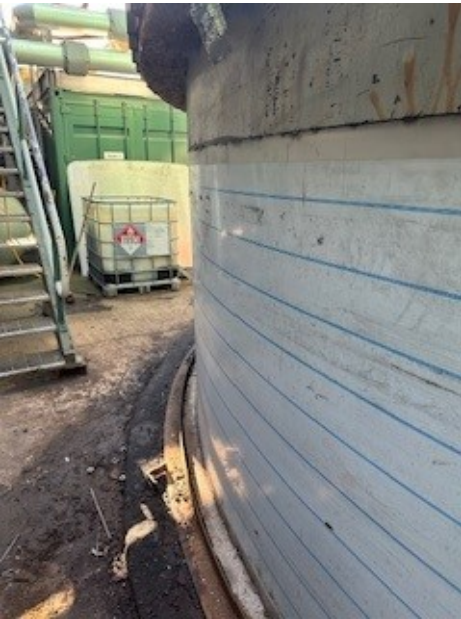
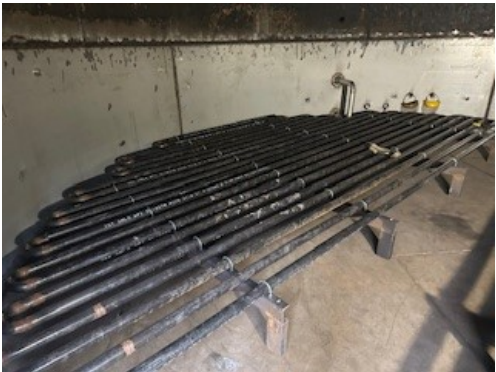
Significant corrosion was discovered at on the steel at the base of the tank walls and further inspection revealed that the thickness of the tank wall had decreased by 75%.

This was due to moisture ingress into the insulation of the tank, with the combination of heat, water and oxygen causing significant corrosion. The images below show the corrosion at the base of the tank.

There are two possible actions to mitigate the effects of moisture on the tank walls:

- Removal of insulation from the base of the tank (100-150mm)
- Incorporation of stainless steel, rather than mild steel for the bottom 1.5m of the tank walls.
