- BITUMEN TANK FIRE 2020

What Happened

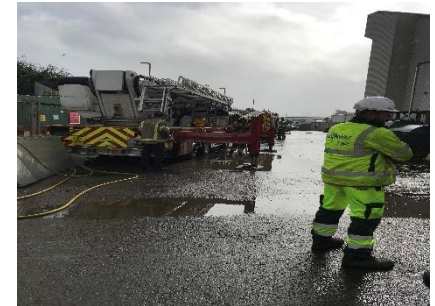
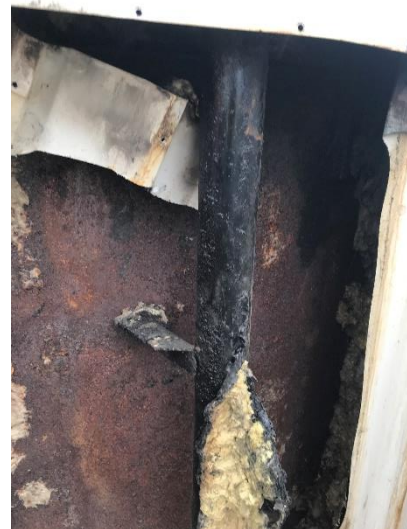
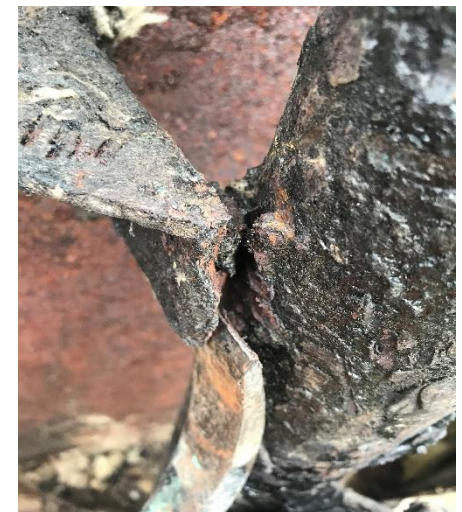
Product identified in cladding and around inlet pipe – no tank fracture and inlet pipe not for that tank

Ignition occurred following morning as a result of heat from the tank allowing lighter oils released from pipework volatilize effect – pipe fracture identified - aged insulation (>20years) disintegrated acting as a wick. By removing the cladding to check issue effectively open to air oxygen introduced and over 8hours unseen smouldering occurred to enable ignition after glowing effect
